Annex B – Results from pilot tests

Annex to Report from Pulling Tests with Used Lashing Equipment

2009-05-26
Peter Andersson
Juraj Jagelcak
Elise Lind

MariTerm AB

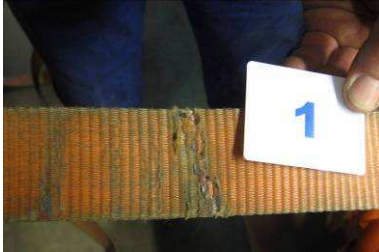
No.	Parameters and remarks	Before test	After test
K1	<p>CORONA – PES web lashing – webbing + hook</p>

<p>- tested place – temperature or chemical damage</p>

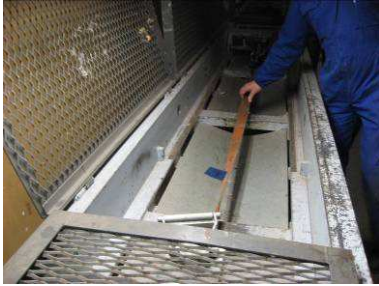
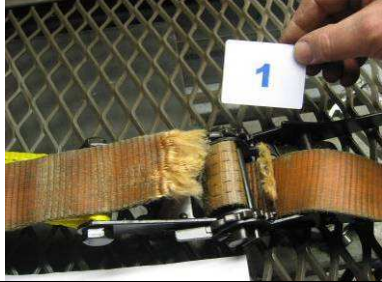
<p>- broke at winch instead of at tested place</p>

<p>Measured BL – 3710 daN</p>
K2	<p>VOLVO PART – PES web lashing – webbing + hook</p>

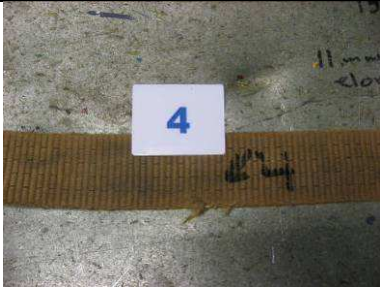
- small edge damage

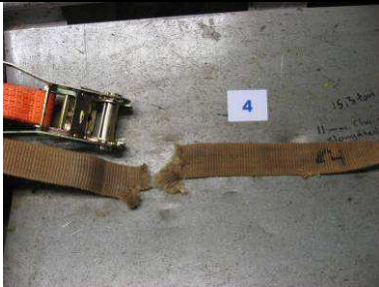
- broke at winch

Measured BL – 3350 daN
K5	Web lashing – webbing + hook Producer: N/A MBL = N/A – (probably 4000 daN - 4 strips) Man. Date: N/A

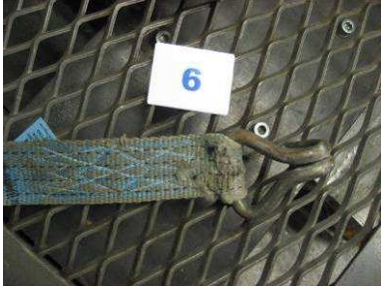
- webbing damaged at hook

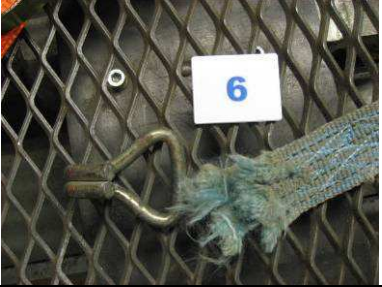
- broke at hook

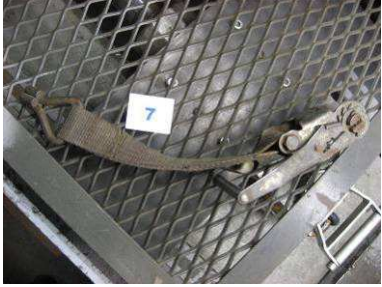
- used old ratchet part – rusty and dirty

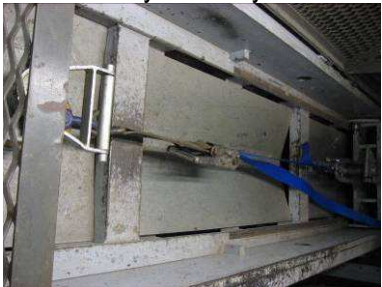
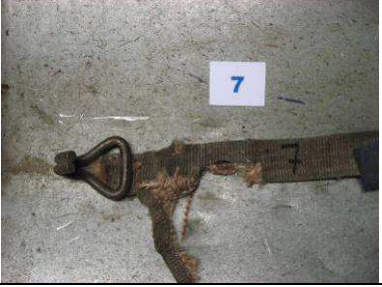
- broke at hook

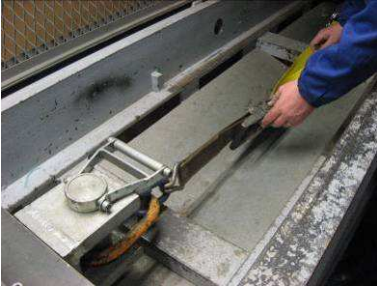
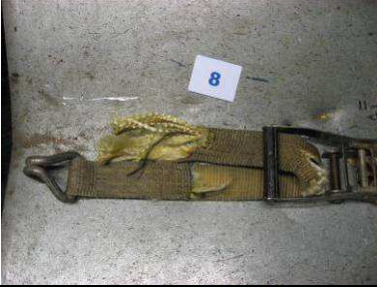
<ul style="list-style-type: none"> - broke in sewing

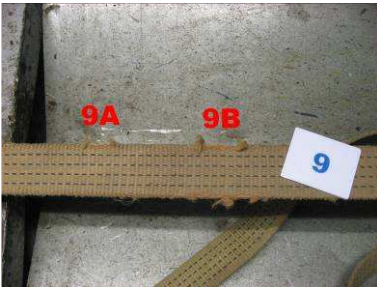
<ul style="list-style-type: none"> - 9A edge damage on one side – 9B edge damage on both sides

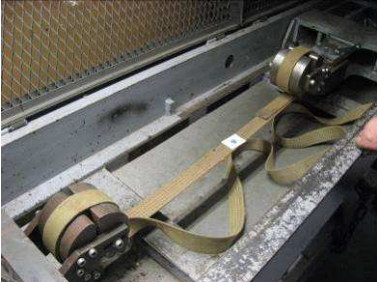
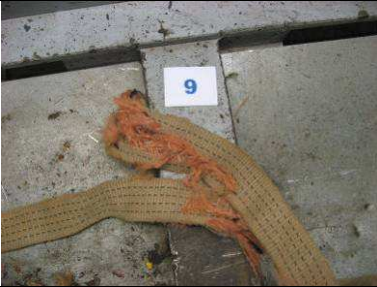
<ul style="list-style-type: none"> - broke in 9B

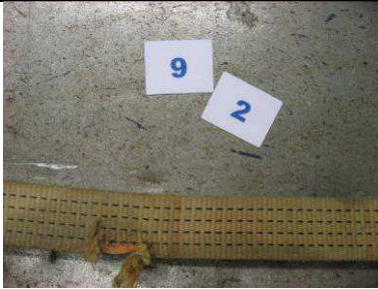
<p>- edge damage</p>

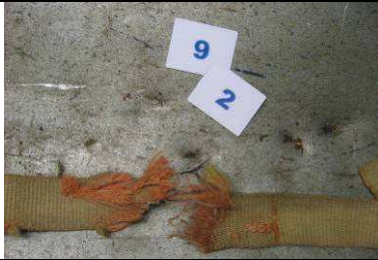
<p>- broke at edge damage</p>

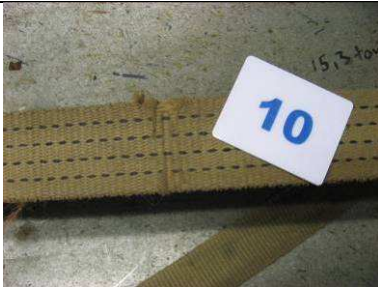
<p>- nick damage</p>

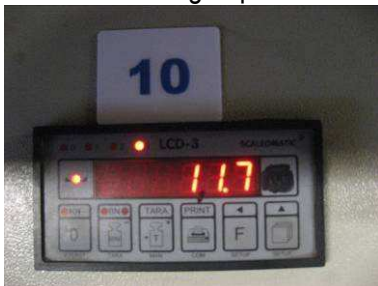
<p>- broke at damaged place</p>

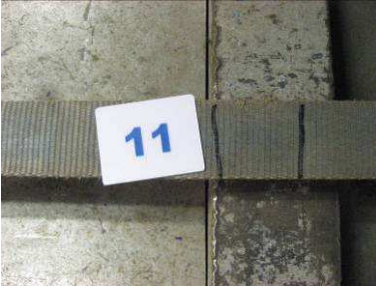
<p>- edge damage</p>

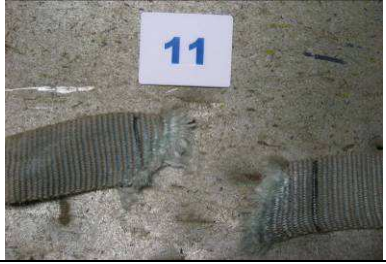
<p>- broke at edge damage</p>

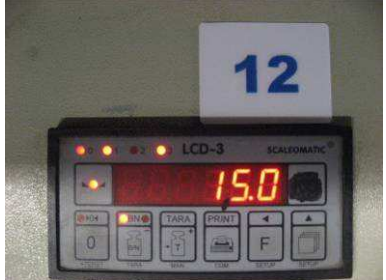
<p>- broke at damaged place</p>

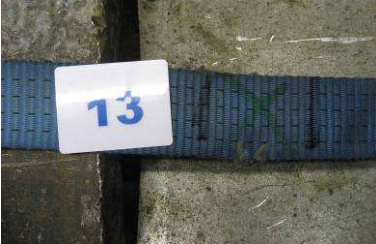
<p>- edge damage</p>

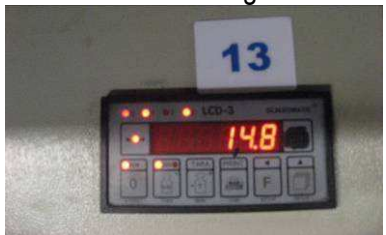
<p>- broke at nick damage</p>

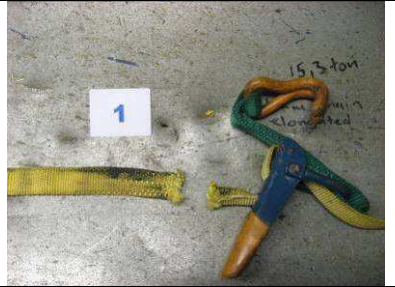
<p>- broke close to buckle</p>

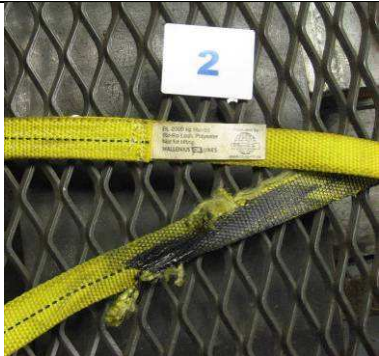
<p>- serious edge damages on both sides and chemical or temperature damage. The lashing was scrapped on board.</p>

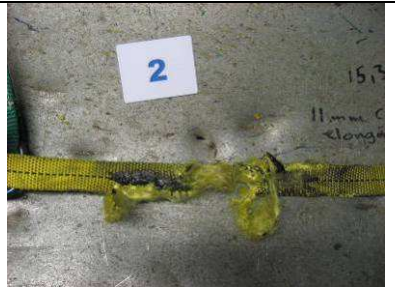
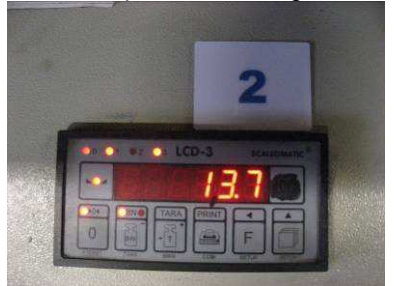
<p>- broke in place of damage</p>

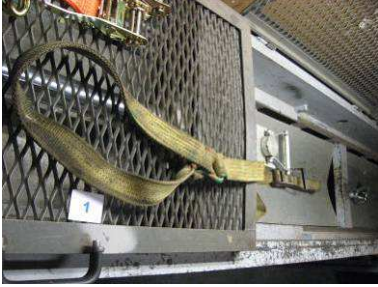
<p data-bbox="683 607 1015 674">- worn but not damaged – scraped on board the vessel</p>

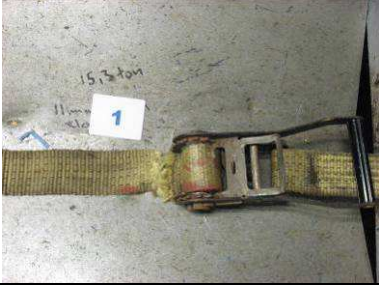
<p data-bbox="1091 607 1278 640">- broke at winch</p>

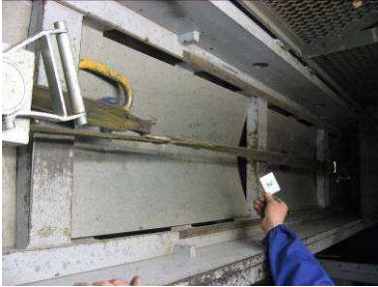
<p data-bbox="683 1288 970 1321">- in good condition - dirty</p>

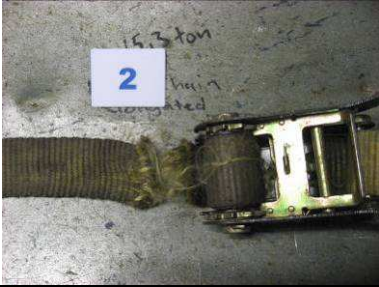
<p data-bbox="1091 1288 1278 1321">- broke at winch</p>

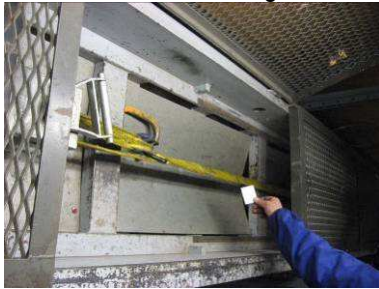
No.	Parameters and remarks	Before test	After test
R3	<p>PES web lashing - yellow Material: PES MBL = 5 tons MSL = 2,5 tons Manufacturer: Ro-Ro Int. – Man. Date: Jun 2005</p>  	  <p>- nick and break damages</p>

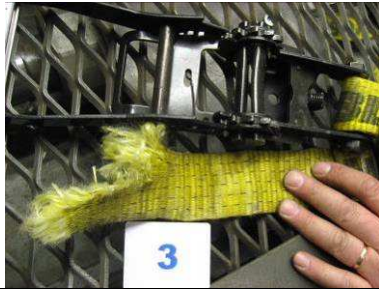
<p>- but broke at winch – winch deformed</p>

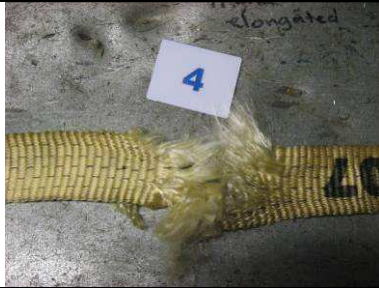
<p>Measured BL – 4790 daN</p>
R4	<p>PES web lashing - yellow Material: PES MBL = 5 tons MSL = 2,5 tons Manufacturer: Ro-Ro Int. Man. Date: 2007/11</p>  	  <p>- very good condition – cut by knife to the depth of 2 strips</p>

<p>Broke at place of cut</p>

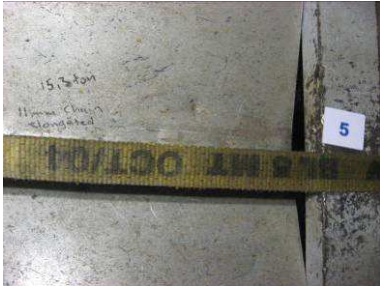
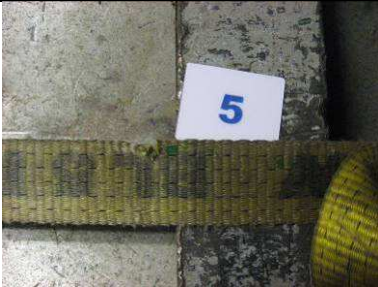
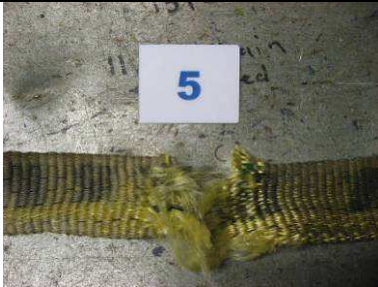
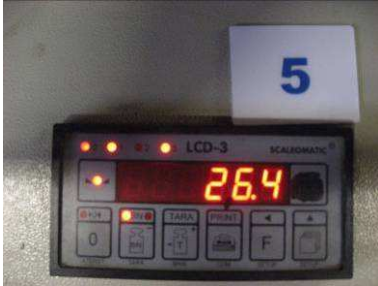
<p>- very good condition – cut by knife to the depth of 1 strip</p>

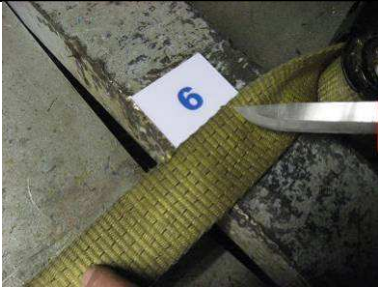
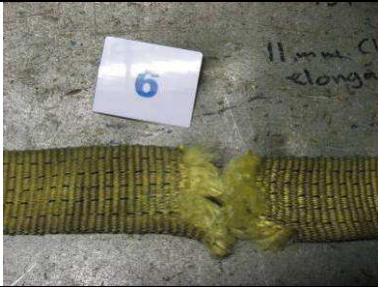
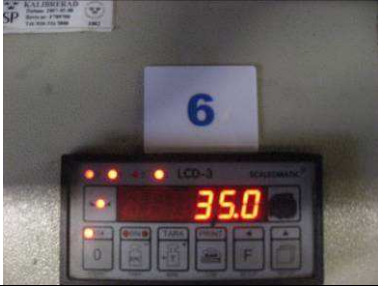
<p>- very good condition – cut by knife to the depth of ½ strip</p>

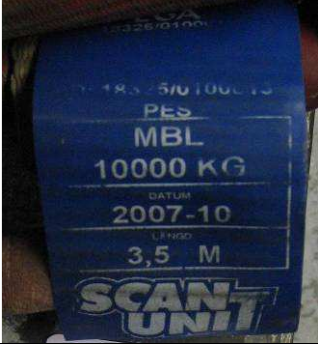
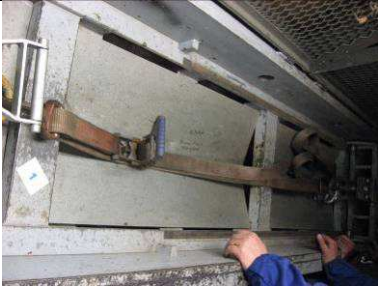
<p>- hanging on vessels' weather deck, no visible damage</p>	  <p>- broke at hook</p>

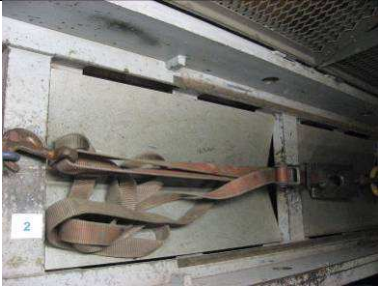
<p>- hanging on vessels' weather deck, no visible damage</p>

<p>- broke at elephant foot</p>

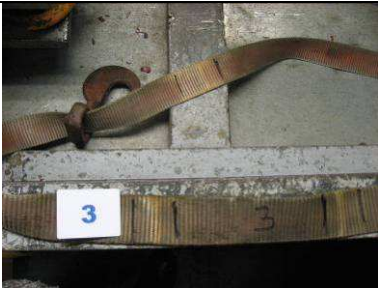
<p>- hanging on vessel's weather deck – worn – 3 places – break damage</p>

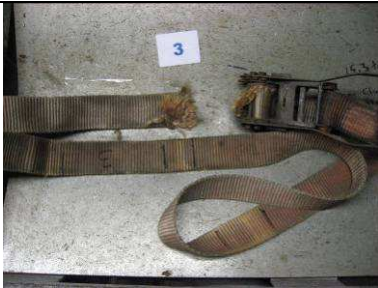
<p>- broke at winch</p>

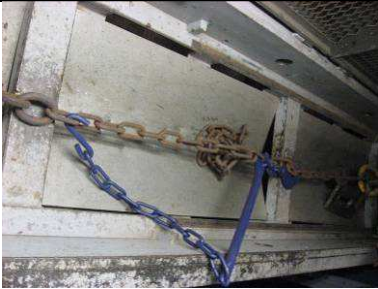
- good condition with new tensioner * MBL = 15 tons MSL = 7,5 tons Manufacturer: ORSA

- new tensioner broke below MBL

* In the tests the tensioner was fixed in one direction in the pulling machine and it could not swing freely. This is probably the reason why the marked MBL was not obtained. New tests will be carried out in the main study.

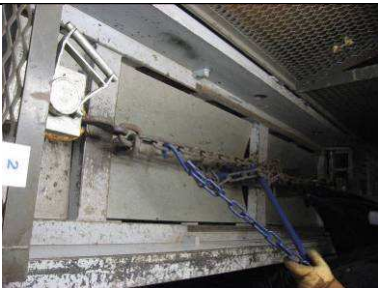
- very good condition with a new tensioner *

- broke at tensioner below MBL

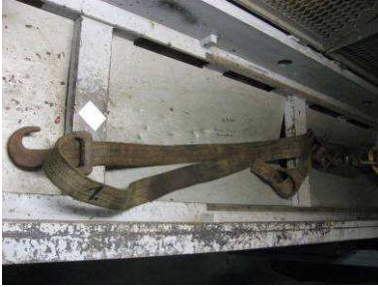
- hanging on vessels' weather deck – rusty and dirty but without visible damage

- broke at hook

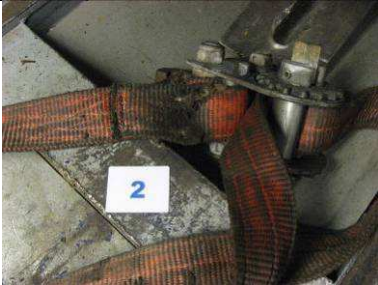
- hanging on vessel's main deck – (0,5 – 1 year old) – damaged at winch

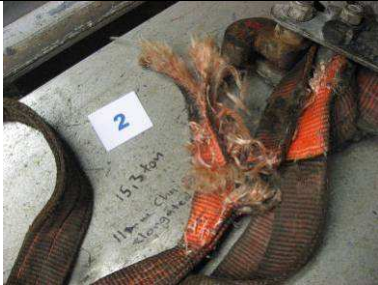
- broke at damaged place

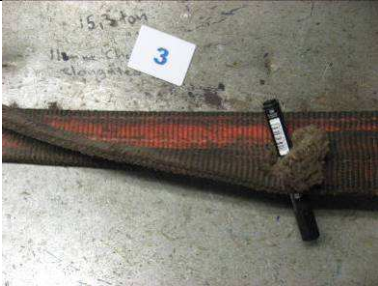
- big tear damage – about 1 year old

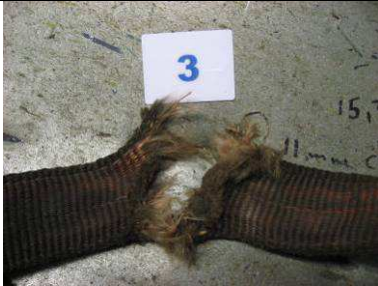
- broke at hole

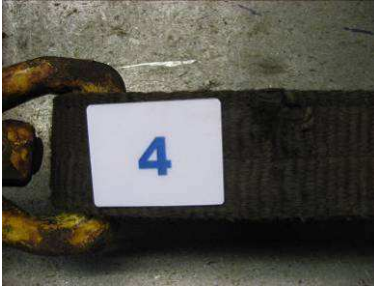
- small fibre damage at hook - dirty

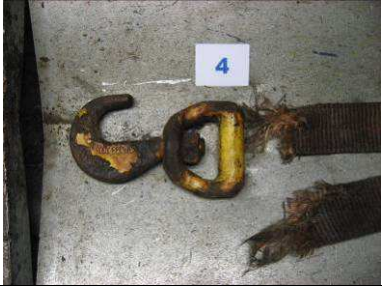
- broke at hook

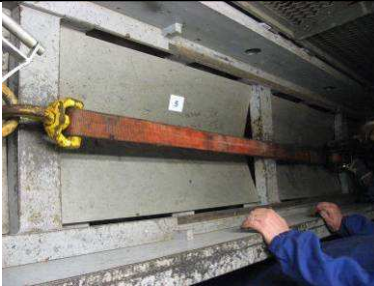
- good condition – used – no visible damage

- broke at hook

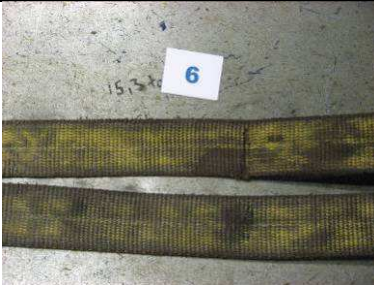
- longer lashing worn – dirty – 1 small edge damage

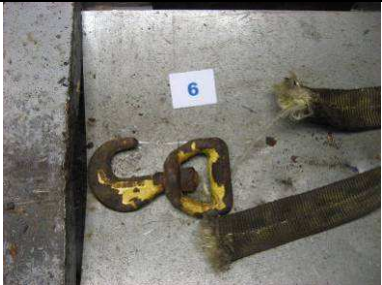
- broke at hook

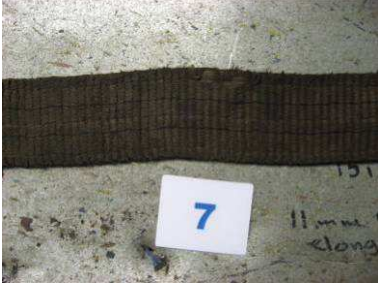
- dirty, small edge damages

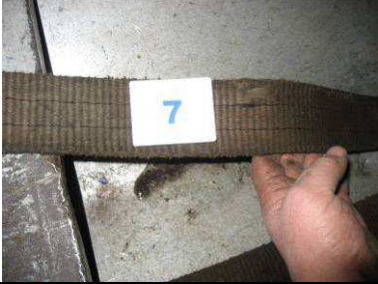
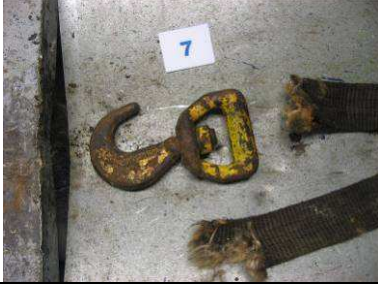
- broke at hook

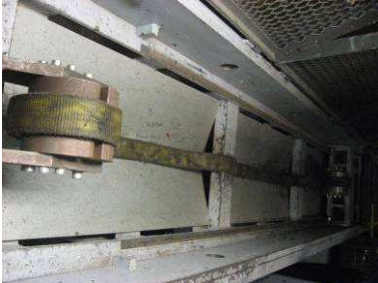
- good condition – used – no visible damage
