# TRANSPORT QUALITY ON RAILWAY REGARDING BREAKAGE

## **Research report by:**

Peter Andersson	MariTerm AB
Nils Andersson	”
Sven Sökjer-Petersen	”
Petra Hugoson	”
Robert Bylander	”

**March 2006**

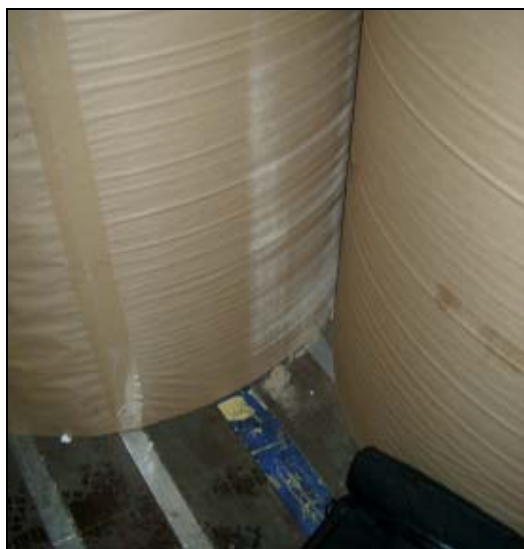
*Shaving damages on standing paper reels in a swap body.*

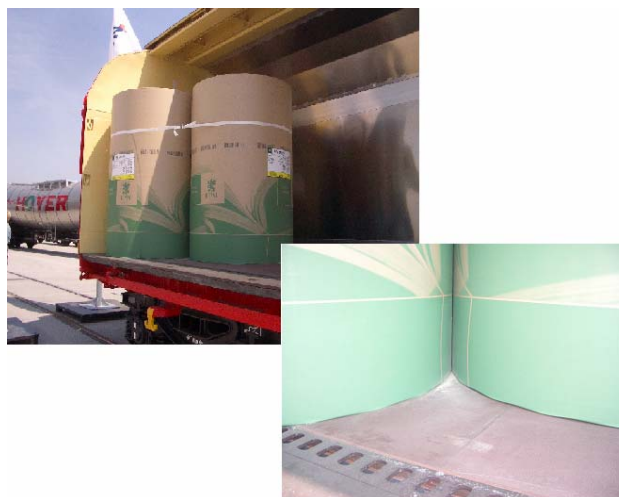
*Shaving damages on standing paper reels in a wagon exhibited at the Transport and Logistics exhibition in Munich in June 2005.*

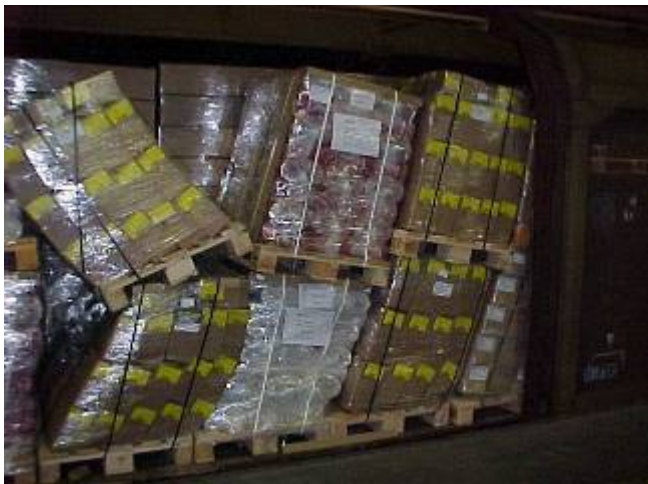
*Typical cargo damage caused by inadequately stowed cargo in combination with heavy shunting forces.*

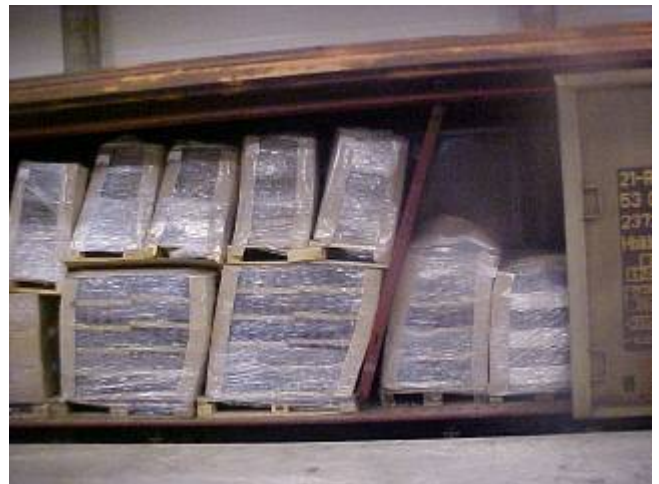
*Cargo damages caused by inadequately stowed cargo and improper use of partition wall.*

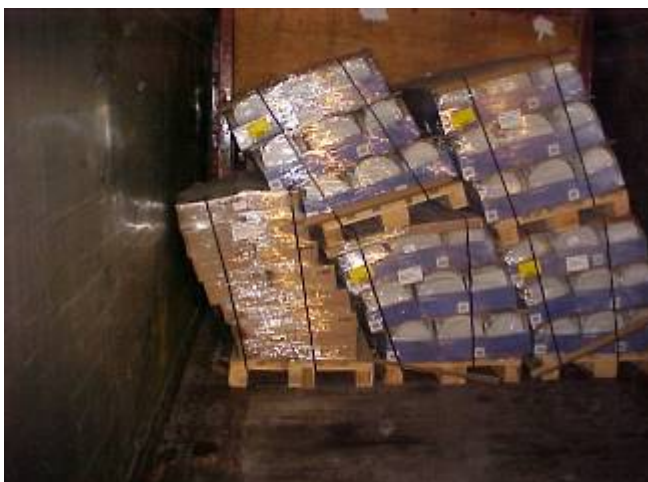
*Dangerously stowed cargo against the side doors of the wagon.*

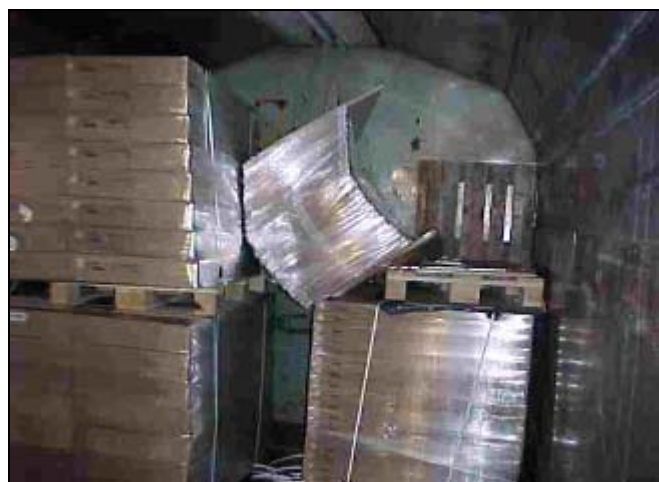
*Improper transverse securing of palletised cargo.*

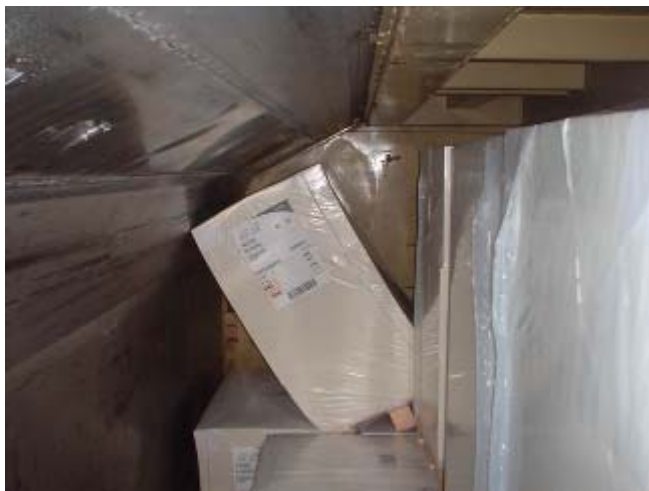
*Improper transverse securing of palletised cargo.*

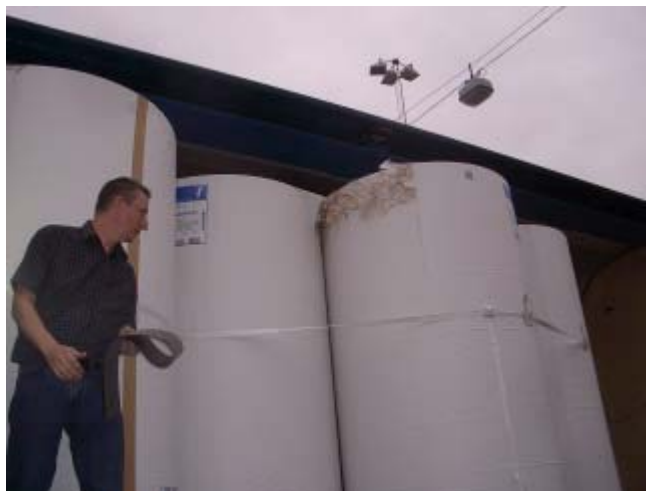
*Typical shaving damage on standing craft liner reels caused by vibrations during transport of test reels from Piteå to Malmö.*

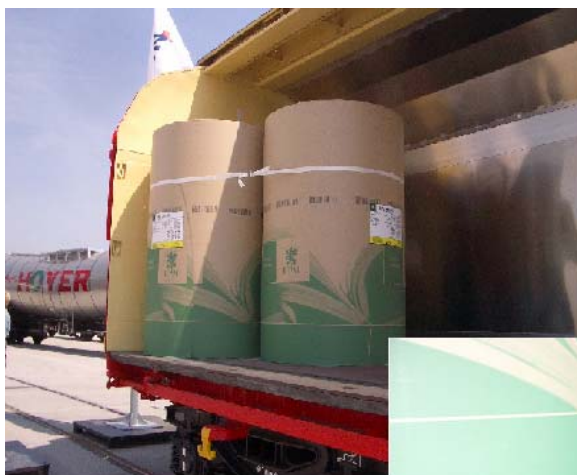
*Shaving damages on standing paper reels in a wagon exhibited at the Transport and Logistics exhibition in Munich in June 2005.*

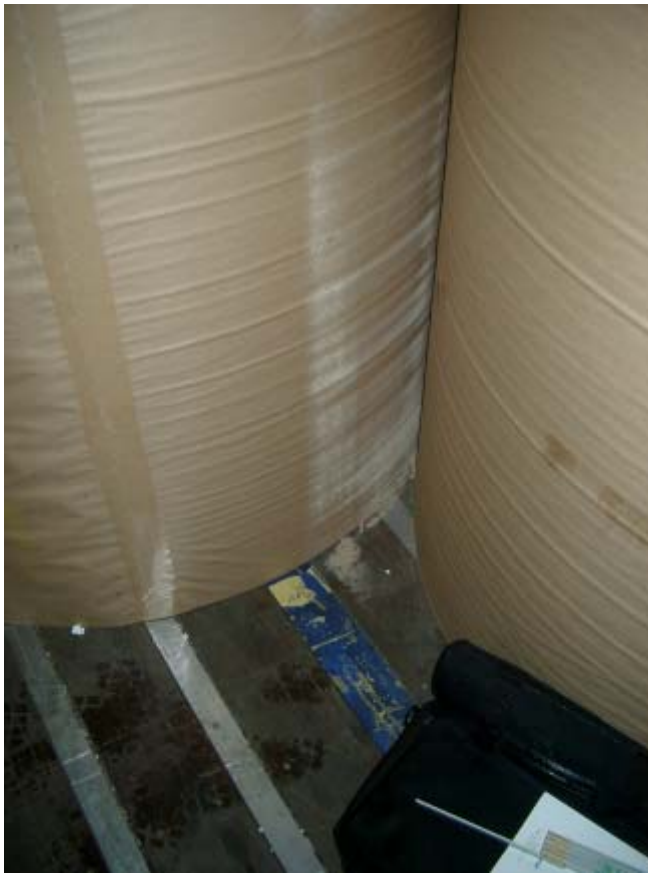
*Shaving damage on standing paper reels in a swap body.*

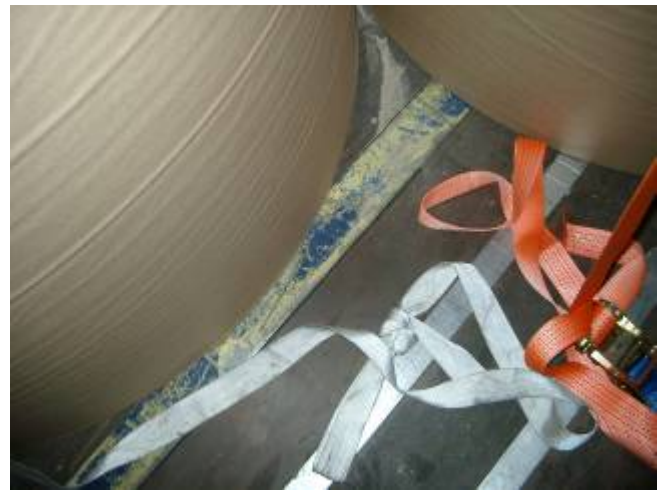
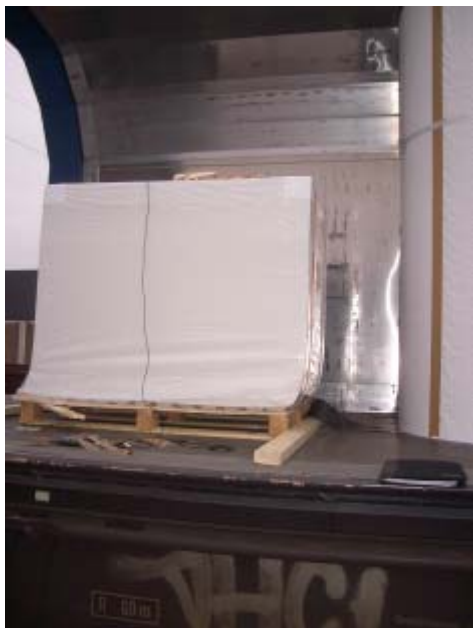
*Pallet with paper sheets deformed during shunting tests.*

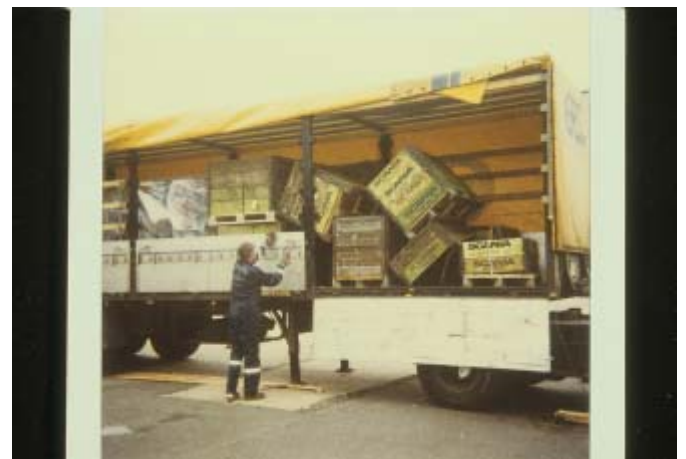
*Pallets falling backwards in a trailer due to improper cargo securing and heavy shunting.*

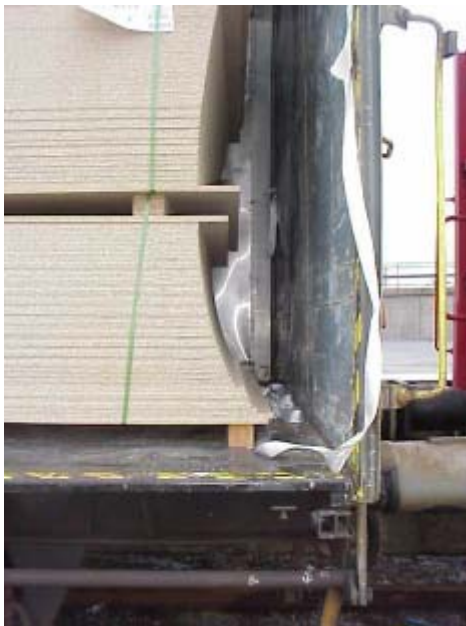
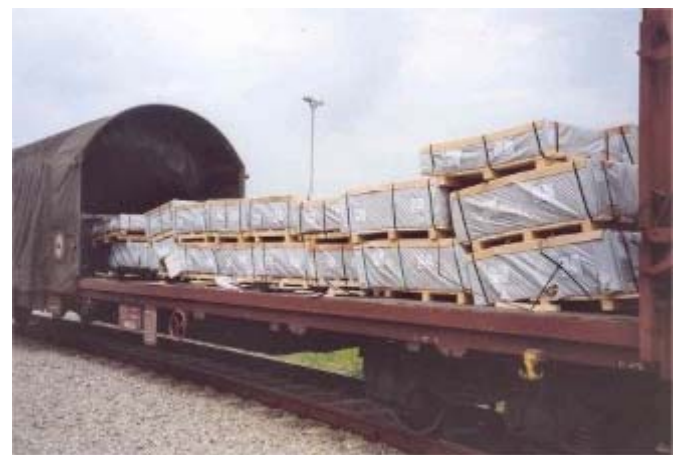
*Typical damages caused by heavy shunting in freight wagons.*

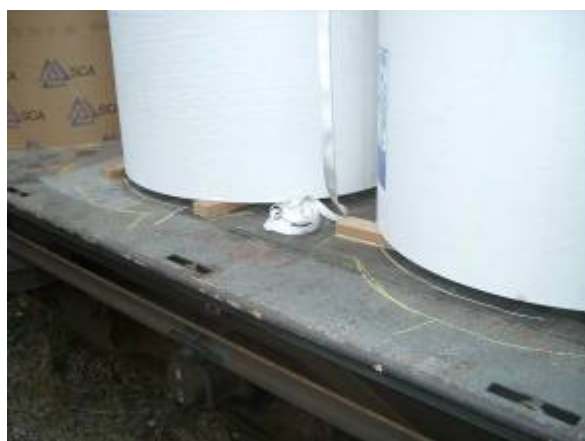
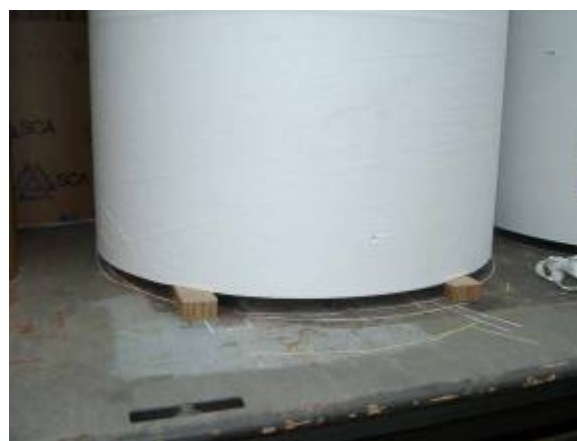
*Reels no 4 – 6 standing on blocks of corrugated cardboard strips here photographed in Hallsberg and Vienna, showed significantly movements in both rotational and longitudinal directions.*

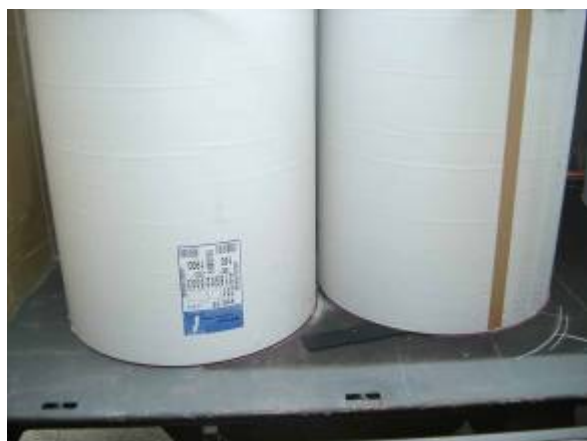
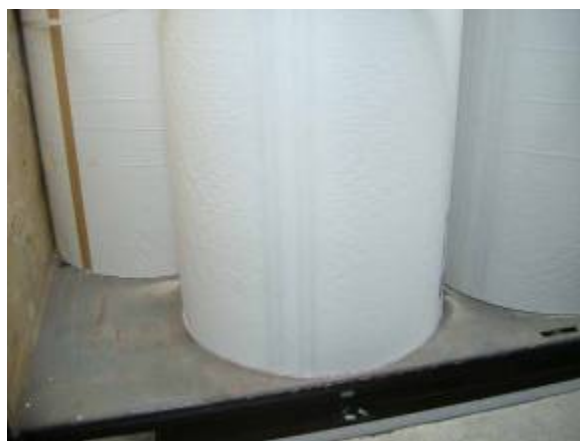
*Photos taken in Vienna of reels no 24 – 27 respective 1 – 4 in the Hirrs wagon. Significant shavings damages were observed between the reels.*

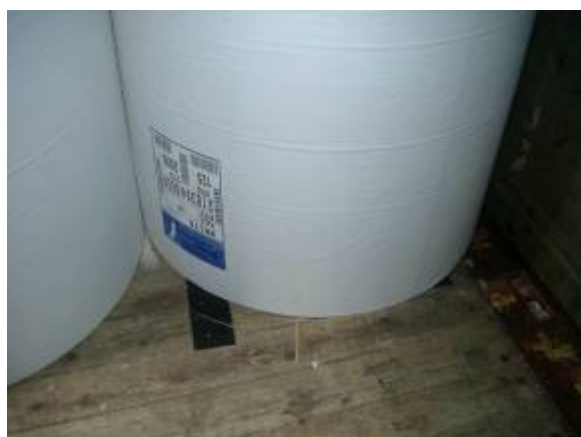
*Shaving damages were observed between reel 3 and 4 in Hallsberg.*

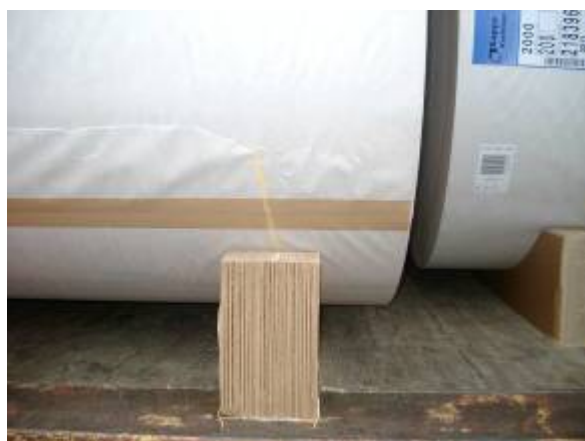
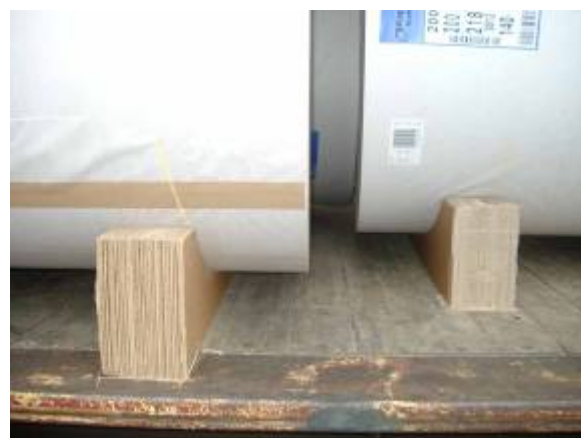
*Significantly linear movements between Hallsberg and Vienna were observed on reel 6 and 7.*

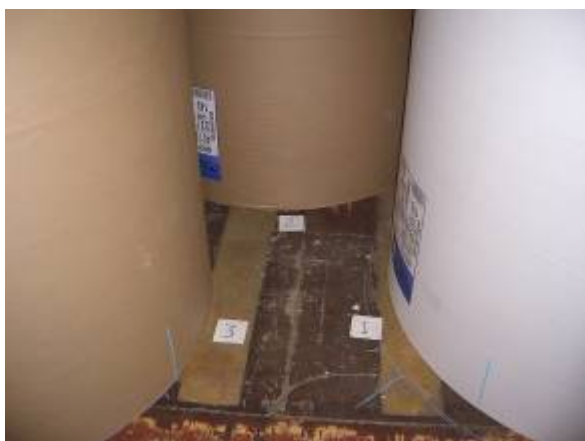
*A significant rotation of reel 1 was observed.*

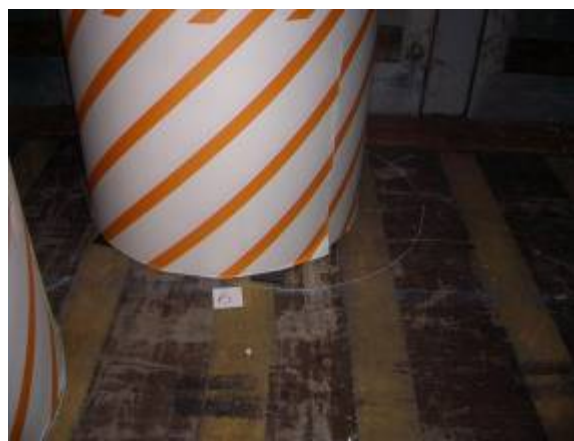
*A linear movement of reel 6 of 25 cm. The rotation was 60 cm along the circumference.*

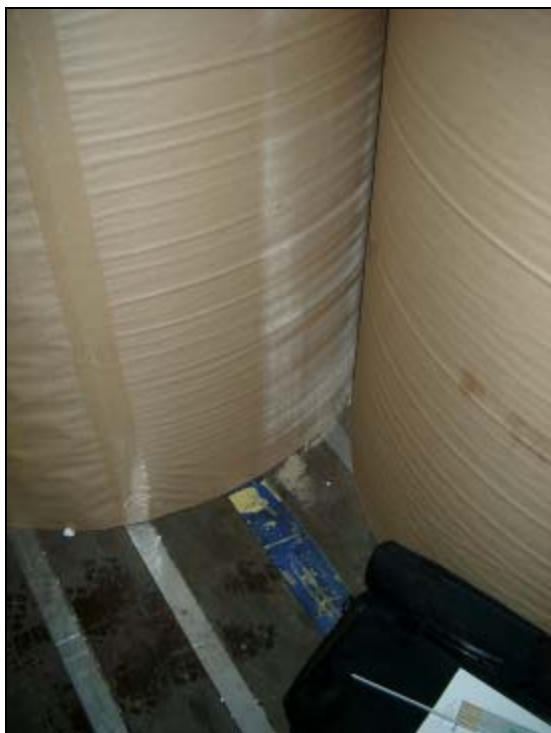
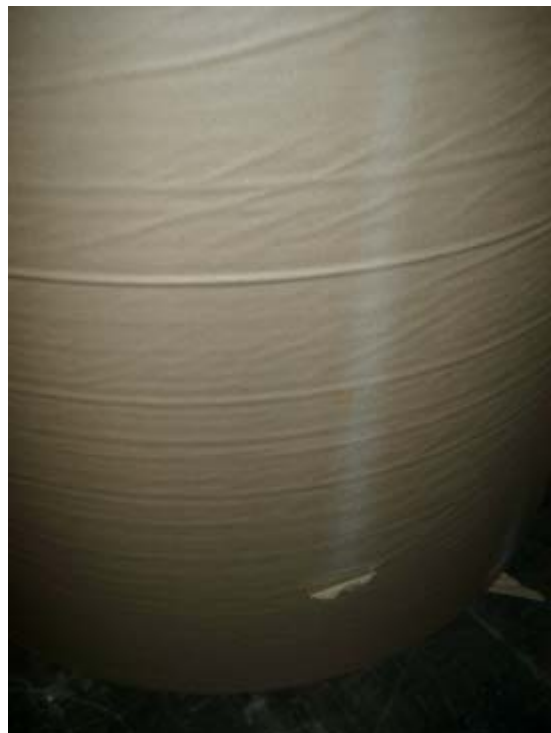
Despite some top-over lashings, round-turn lashings and supporting edge protectors between the top-over lashings and the reels, significantly shavings were observed between several reels in the swap bodies. The inspections, however, showed that the paper reels in the swap bodies were not secured according to current rules for neither road transports nor intermodal transports on railway. The reels had been loaded at a paper mill in Norway.

*Extensive shaving damage*

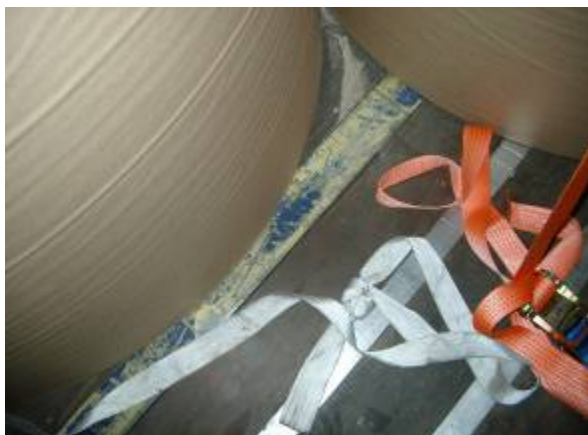
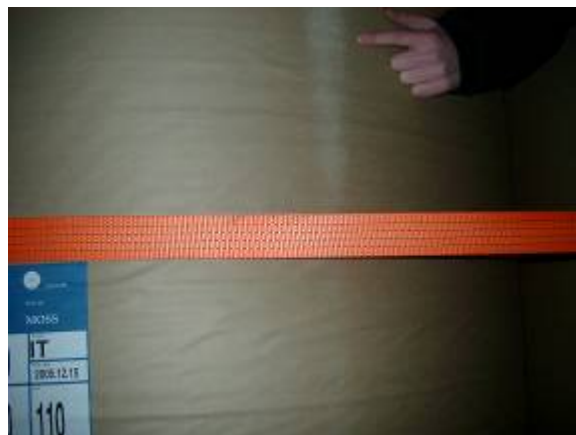
*Shaving damages*

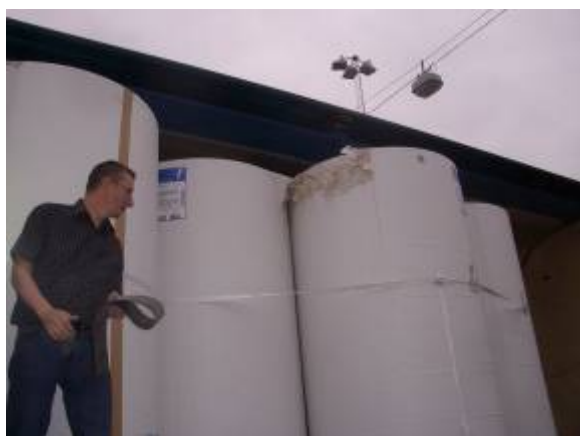
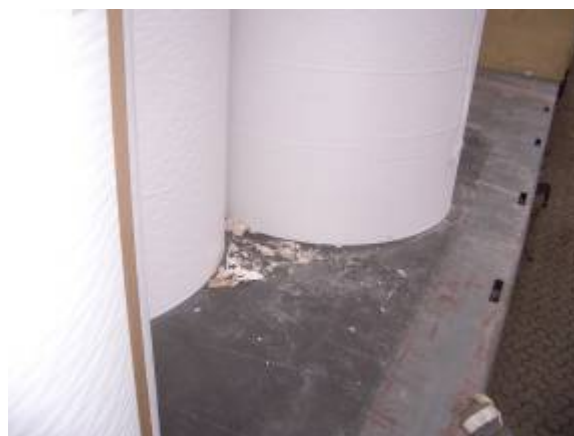
It is notable that heavy shaving damages were observed prior to the impact tests, on the reels that were not standing on rubber strips.

*The heavy shaving damages on the reels that were not standing on rubber strips. The damages were observed prior to the impact tests.*

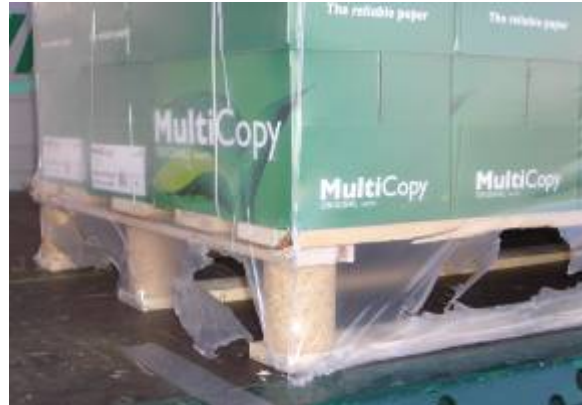
*Shrink hood pallet 1 and 3.  
The plastic film has been torn apart when handled by a fork lift.*
