Report from Pulling Tests with Used Lashing Equipment

*Pilot test performed at Ro-Ro International in Gothenburg 2009-01-16,
Main tests performed at Forankra in Vårgårda 2009-04-15 and at
Ro-Ro International in Gothenburg 2009-04-16*

MariTerm AB

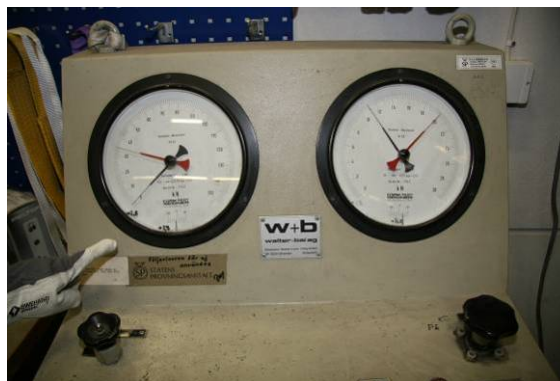
Test pull machine at Forankra

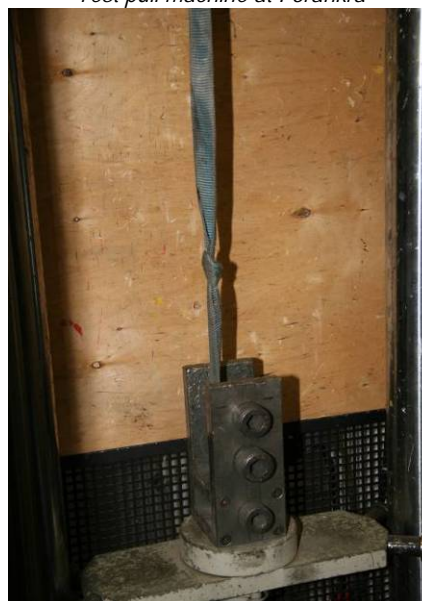
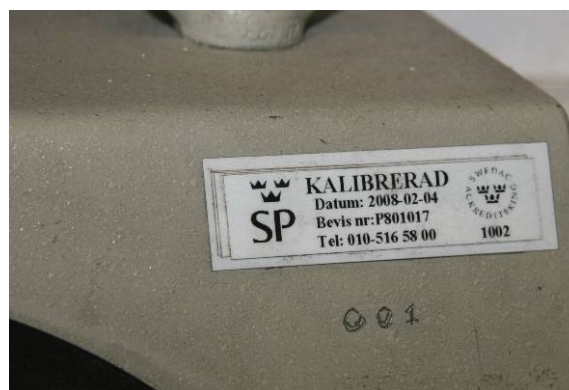
The pulling machine was calibrated 2008-02-04.

Test machine with the calibration marking

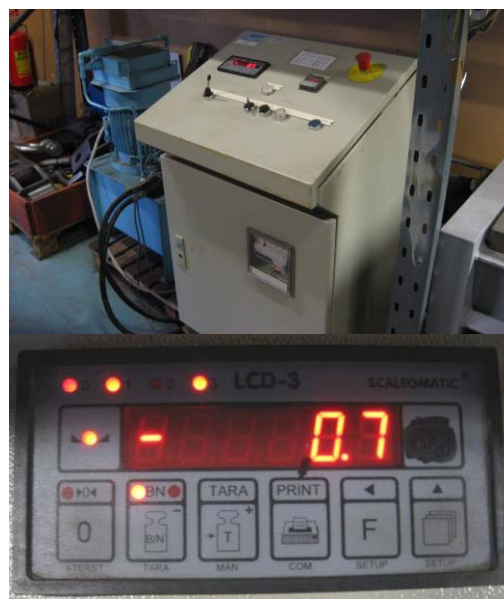
Test pull machine at Ro-Ro International

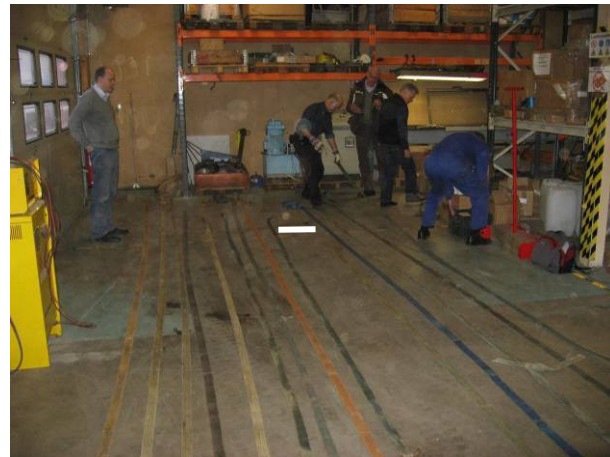
- the web lashings were of different age and conditions with wearing, edge and fibre damages
- in the pilot study some lashings were of unknown minimum breaking load (MBL) without or with unreadable identification tags. In the main study only marked lashings were tested
- material: polyester (PES) and some polypropylene (PP)
- MBL – 4 to 5 ton

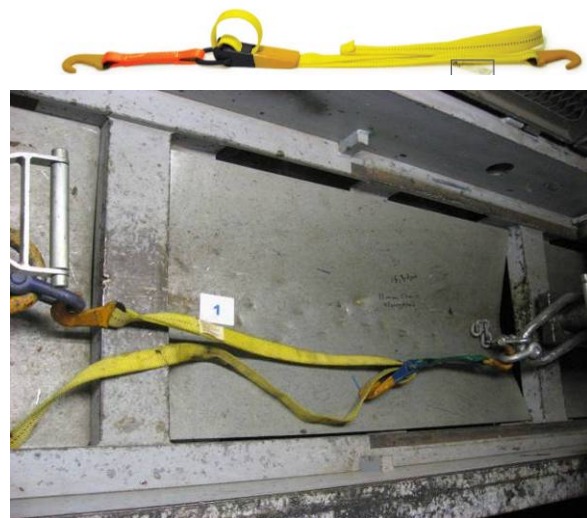
MBL = 2 tons, MSL = 1 ton

*Car lashing - W&W*

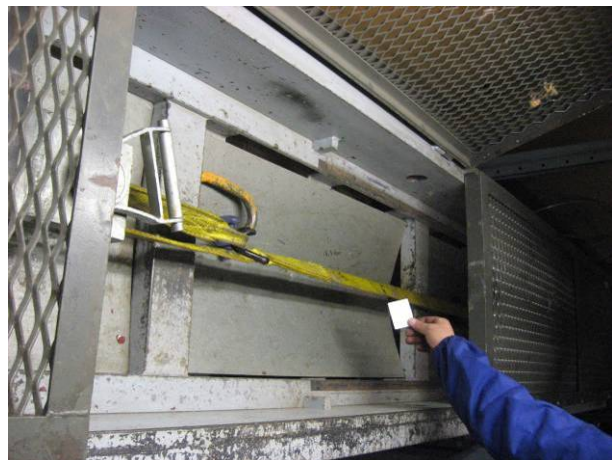
The Rollashings were collected on board of Wallenius Wilhelmsen Lines' Ro-Ro vessels. The lashings consist of web lashing with a ratchet tensioner.

Material: PES
 MBL = 5 tons
 MSL = 2,5 tons
 Manufacturer: Ro-Ro Int.

*Rollash - W&W*

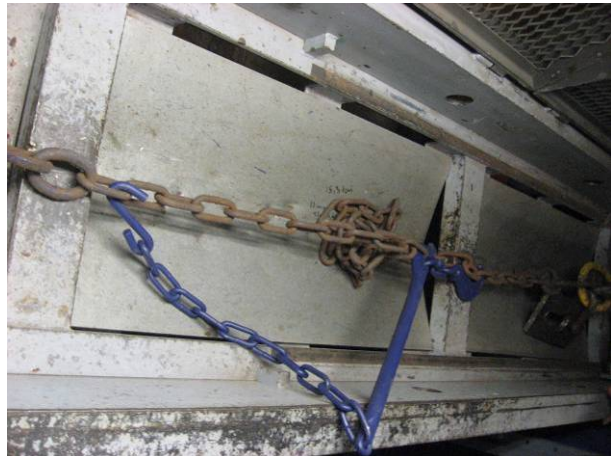
The chains were collected on board of Wallenius Wilhelmsen Lines' Ro-Ro vessels. The used lashings consist of steel chain. The chains were tested with new, used or no lever tensioner.

Material: Steel – 11 mm, Class 8 (grade 80)
 MBL = 15 tons
 MSL = 7,5 tons
 Manufacturer: Orsa Link AB
 Supplier: Ro-Ro Int.

Chain lashing – W&W

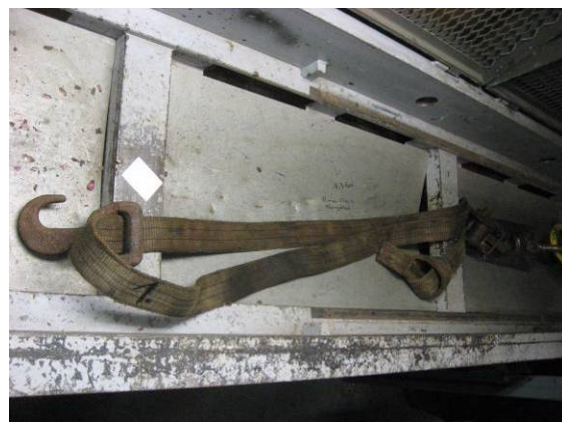
Material: PES
 MBL = 20 tons, MSL = 10 tons
 Manufacturer: Ro-Ro Int.

Trailer web lashing – DFDS Tor Line

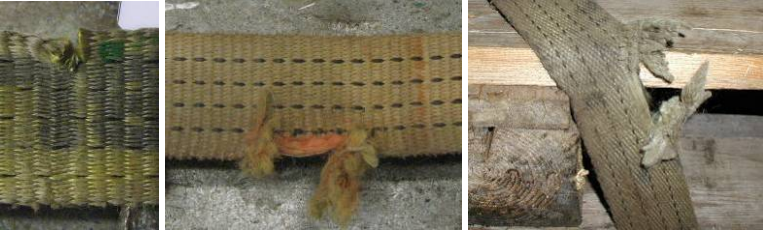
Type of damage	Examples
ED – Edge damage; cut of fibres on the side of the webbing

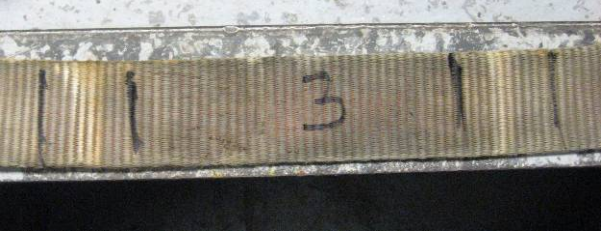
BR – Break damage; compression of the webbing by high pressure

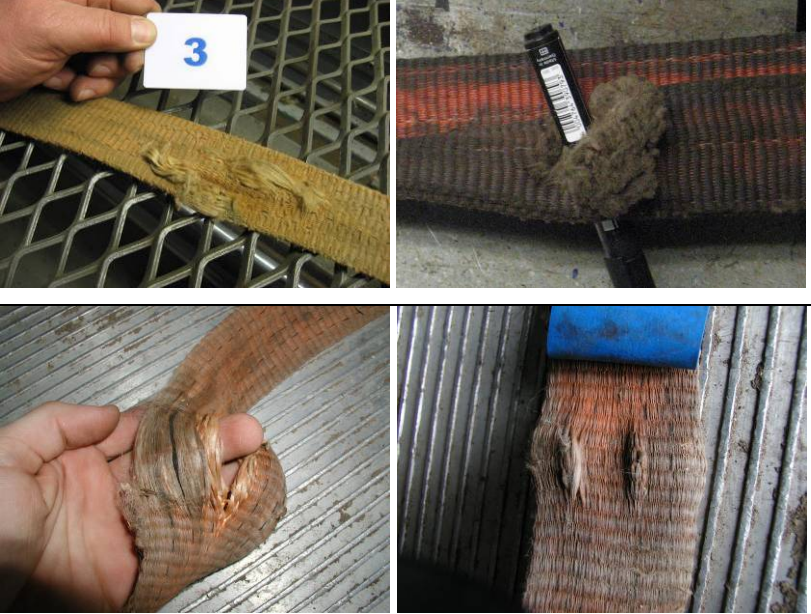
TE – Tear damage; mainly damage of transverse fibres

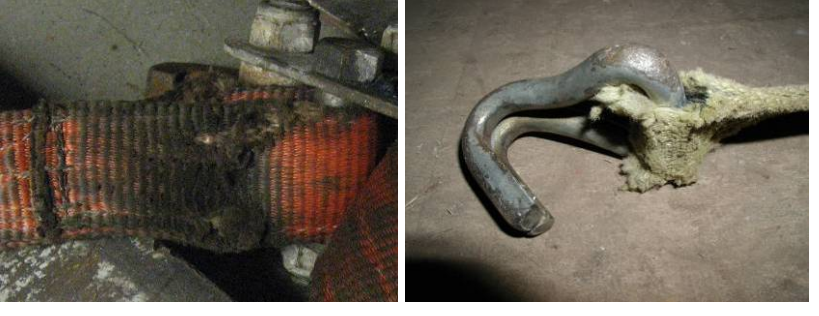
FD - Wear at lashing fittings

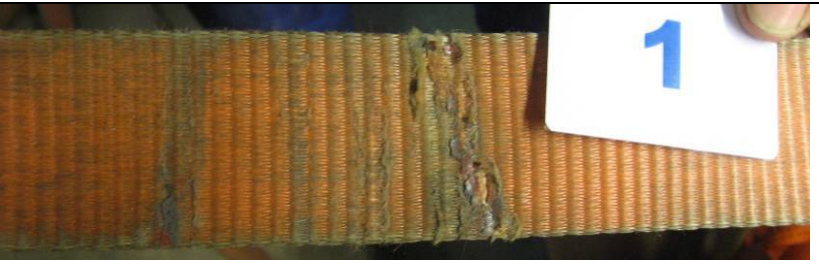
B/C – Burn or chemical damage

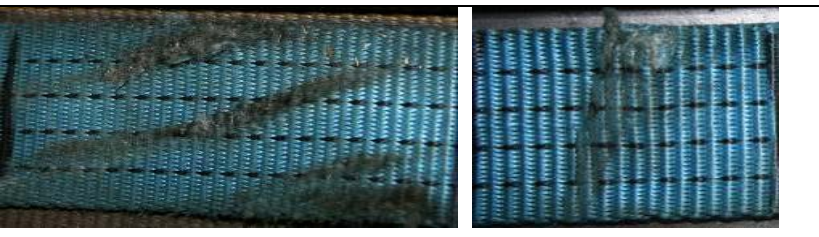
WE – Wear damage, damages caused by friction

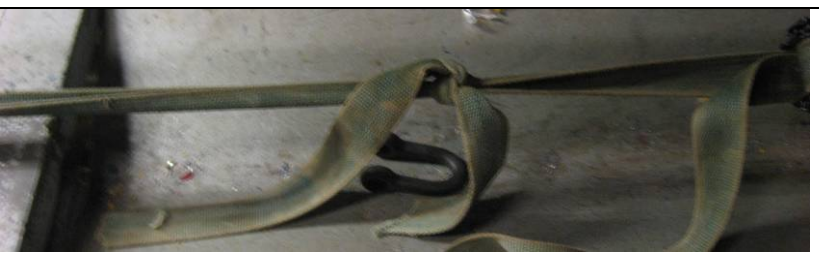
KN - Knot

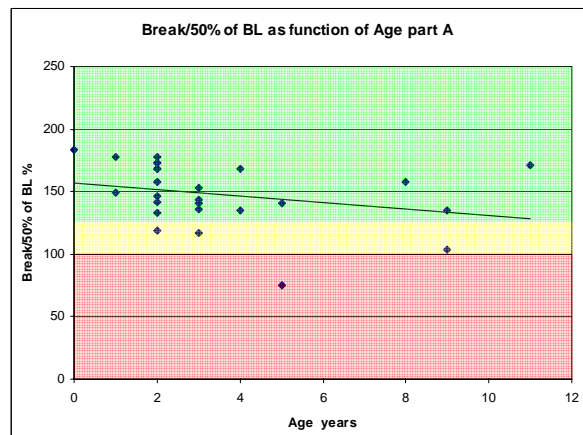
Remaining strength as function of age for undamaged lashings part A

From the diagram it can be seen that the age has little influence on the remaining strength of the lashings as long as they show no damages. It can, however, also be noted that there is a large spread of the results and in some cases the remaining strength has dropped considerably also in these undamaged lashings.

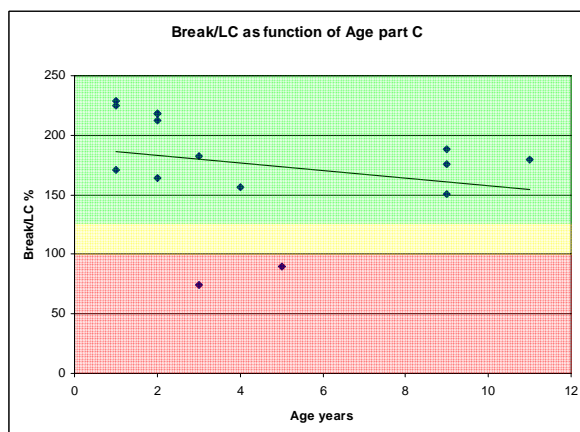
Remaining strength as function of age for undamaged lashings part C

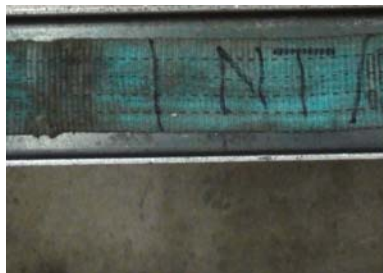
25.A; Dirty and worn

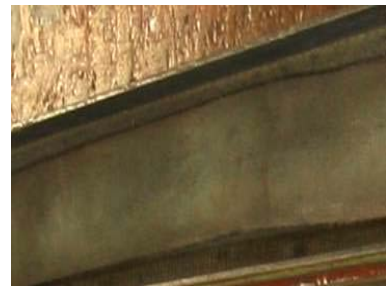
23.A; Very dirty and swollen

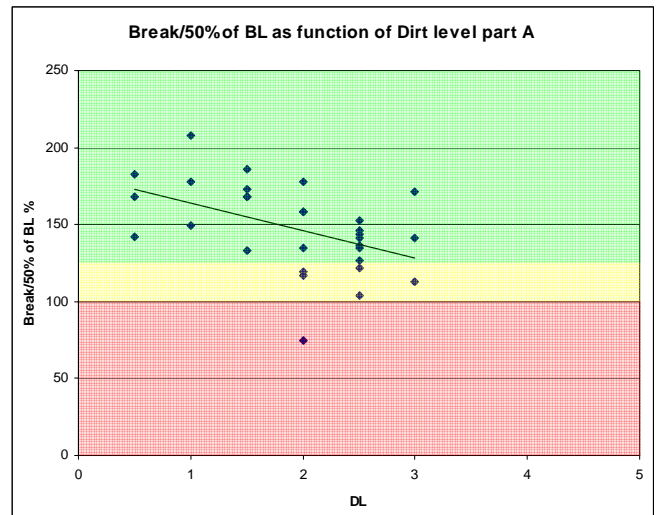
Results of tests with part A, the least worn part of the lashings

From the diagrams it can be clearly seen that there is an obvious correlation between the remaining strength and the dirt level. It can also be noted that dirt itself without additional damages seldom is a reason for condemning this type of lashings.

As it is the same lashings shown in the left and the right diagrams more results are found in the yellow and red parts in the right diagrams as a larger force is allowed in the lashings during sea transport than during road transport. This also shows that for sea transports the scrapping tolerance must be stricter.

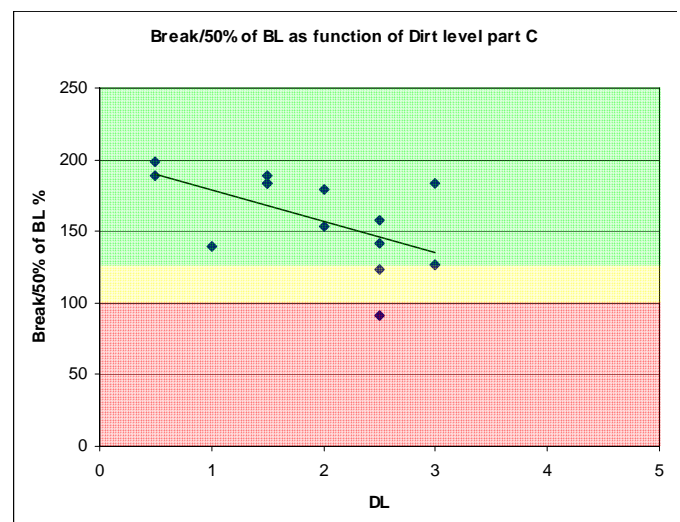
Results of tests with the part C, the most worn part of the lashings

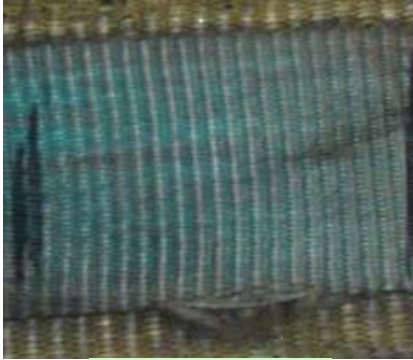
11.B-1 146% of MSL

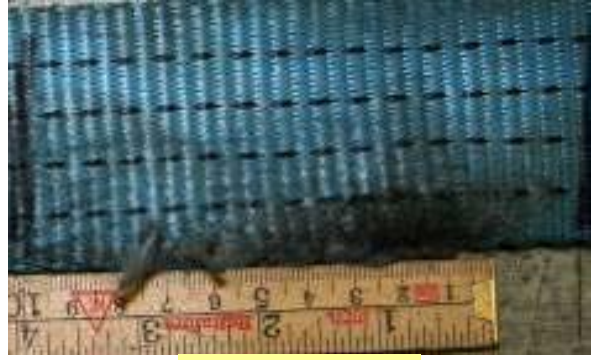
16.B-1 108% of MSL

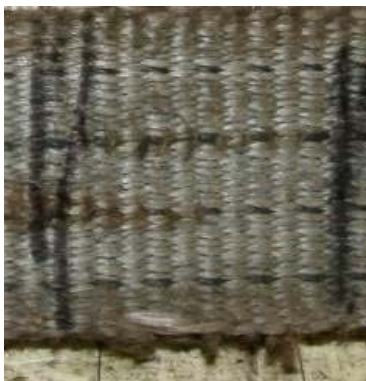
14.B-1 93% of MSL

Lashing 14 had a dirt level of 3, but part A of the lashing showed acceptable remaining strength (173 and 141% respectively). The very small edge damage classified as 0,5 only in 14.B-1 made the lashing break at an unacceptable level (114 and 93%).

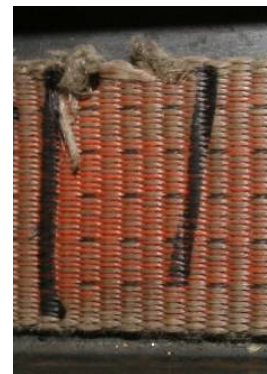
31.C 46% of MSL

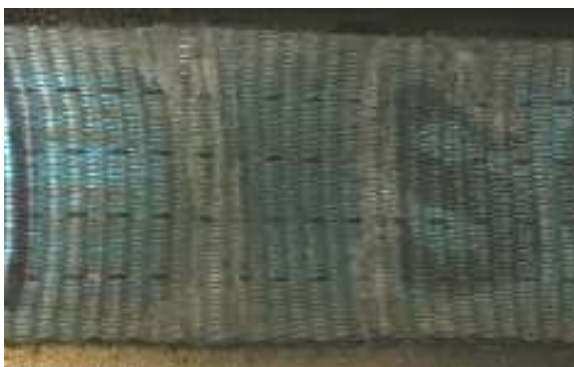
18.C 101% of MSL

Also for cut damages there seems to be a correlation between the remaining strength and the degree of damage. Test 18.C shows that also small cut damages (level 1) can reduce the remaining strength to unacceptable levels.

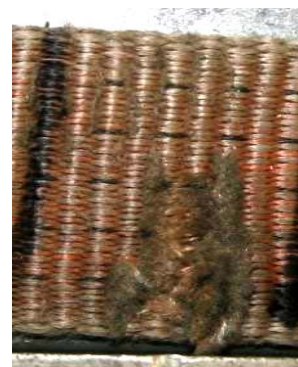
31.B-2 35% of MSL

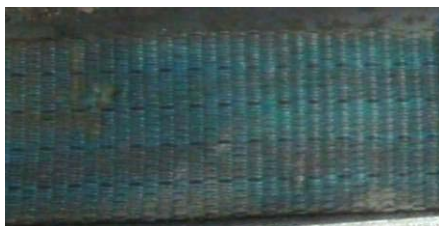
24.B-1 70% of MSL

Only very few of the wear damaged lashings showed acceptable remaining strength. Test 24.B-1 shows that also a very small wear damage (level 1) made the lashing break at an unacceptable level.

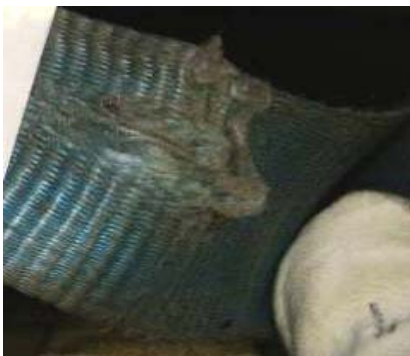
25.B-1 95% of MSL

The tests show that there is no correlation between the remaining strength and the level of tear damage. A very large tear can have low influence on the remaining strength while a small damage as in 25.B-1 can have a significant influence.

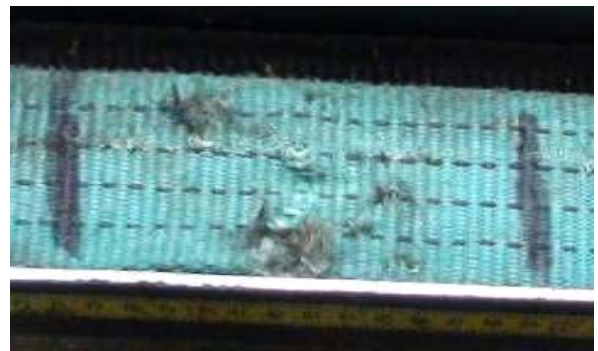
04.B-4 46% of MSL

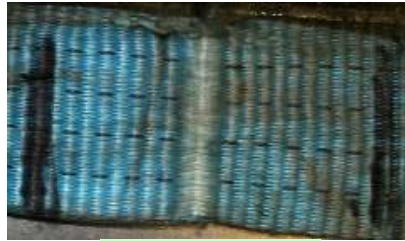
27.C 153% of MSL

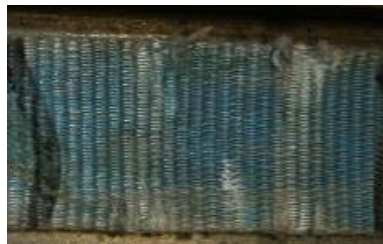
24.C 78% of MSL

Only very few of the tested lashings had break damages and there is no obvious correlation between the remaining strength and the level of damage. Test 24.C shows that also a limited damage can give a large reduction in remaining strength.

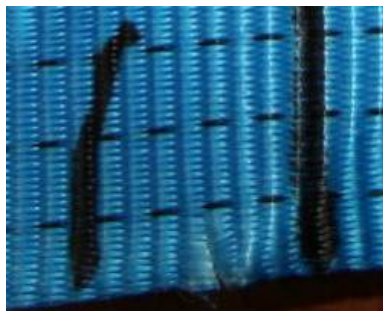
Cut 10 mm ~ 108% of MSL

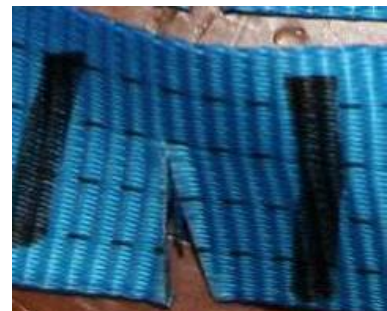
Cut 30 mm ~ 56% of MSL

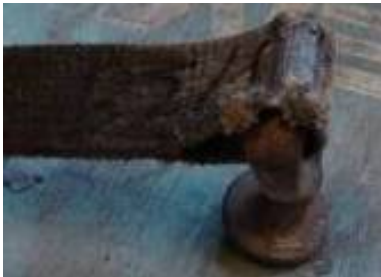
45 100% of MSL

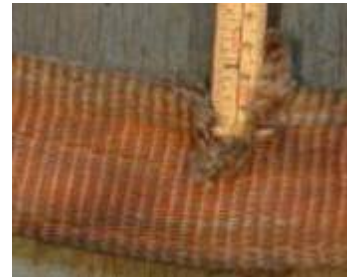
59 66% of MSL

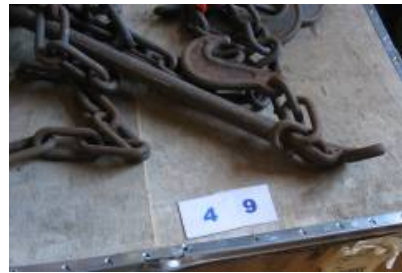
49 after

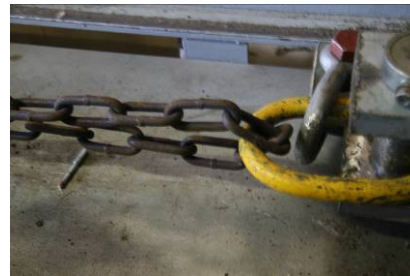
Test 69 with a 11 mm chain drawn around a ring with steel thickness 25 mm. The chain broke at 228 % of MSL.

As can be seen in test 69 with a chain drawn around a 25 mm round bar, this does not influence on the strength of the chain.

A 11 mm chain drawn around a round bar with a diameter of about 25 mm showed surprisingly full strength, and it could thus be concluded that it is allowed to use chains around lashing fittings as on the photo. It shall, however, be noted that the link will be deformed and has to be replaced if the force in the lashing becomes large.
