Annex B – Results from pilot tests

Annex to Report from Pulling Tests with Used Lashing Equipment

2009-05-26
Peter Andersson
Juraj Jagelcak
Elise Lind

MariTerm AB

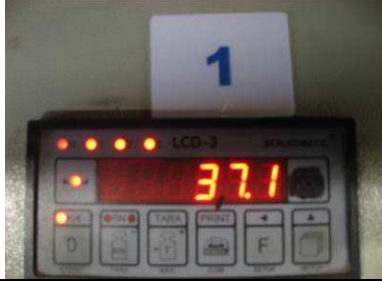
<p>- broke at winch instead of at tested place</p>

<p>Measured BL – 3710 daN</p>
K2	<p>VOLVO PART – PES web lashing – webbing + hook</p>

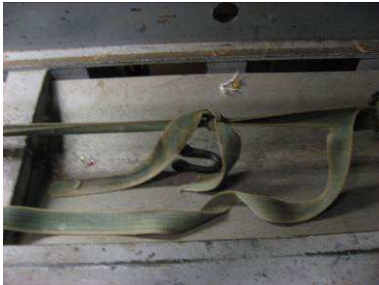
<p>- knotted</p>

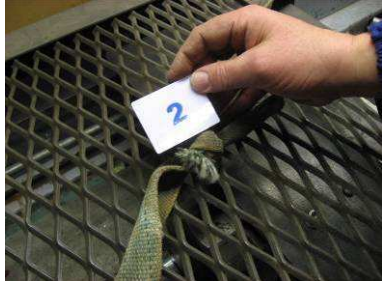
<p>- broke in knot</p>

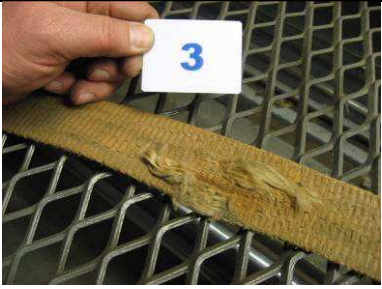
- large tear

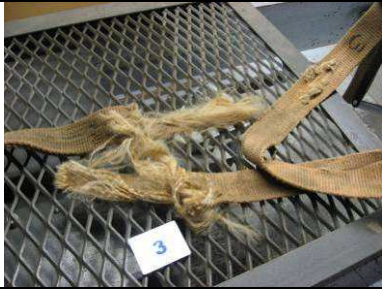
- broke in another place close to identification tag and seam

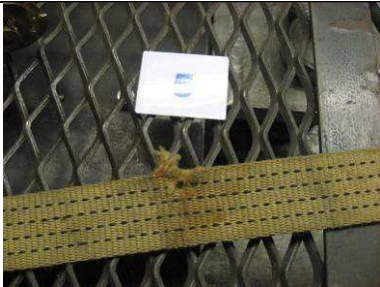
- 5A edge dam + nick

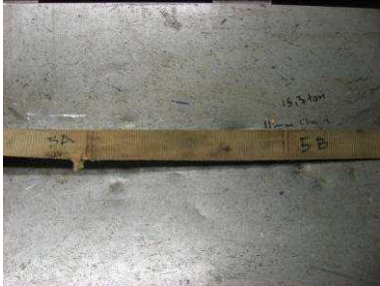
- 5A, 5B - nicks

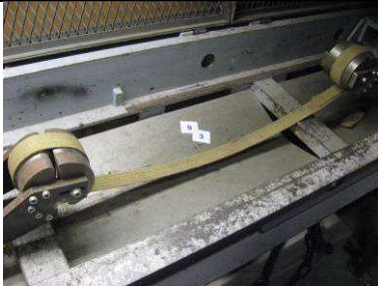
<p>- no visible damage</p>

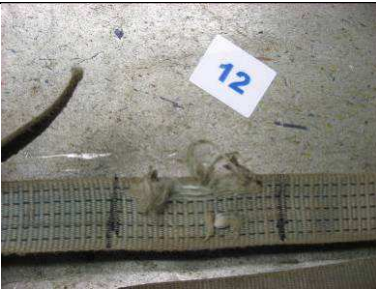
<p>- 2 tears</p>
