# TRANSPORT QUALITY ON RAILWAY REGARDING BREAKAGE

## **Research report by:**

Peter Andersson	MariTerm AB
Nils Andersson	”
Sven Sökjer-Petersen	”
Petra Hugoson	”
Robert Bylander	”

**March 2006**

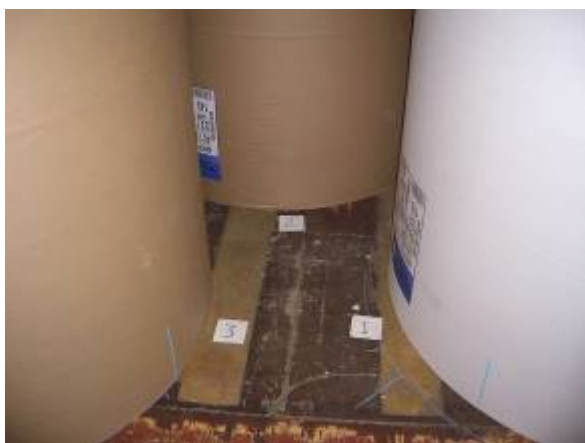
Both wrapped and unwrapped reels from Kappa were shipped from Piteå to Eslöv in a similar wagon with friction enhancing material. Most reels moved significantly regardless of the securing method used and the favourable behaviour of the Stora Enso reels in the previous test can neither be credited the wagon flooring nor the wrapping material of the reels.

*Wrapped and unwrapped Kappa reels transported from Piteå to Eslöv.*

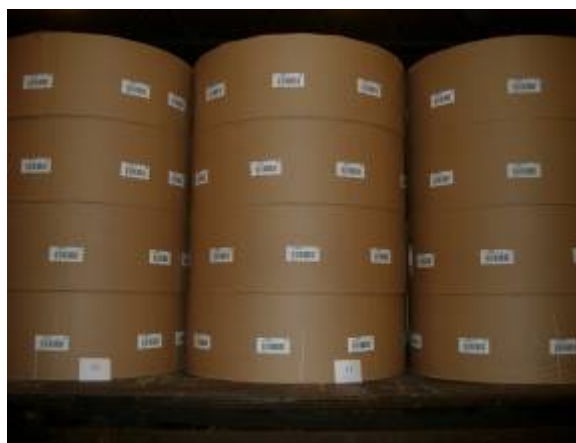
A third test transport was done between Fors and Trelleborg with Stora Enso reels loaded into a wagon without the friction enhancing coating. All the stacks of reels had been dislocated approximately 10 cm in the same direction. This was most likely caused by one or several impacts during shunting. The reels had not moved around stochastically or rotated due to vibrations.

*Stora Enso reels transported from Fors to Trelleborg.*

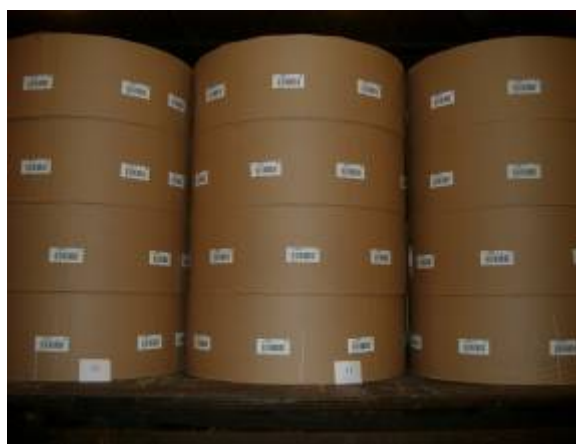
En tredje testtransport genomfördes mellan Fors och Trelleborg med Stora Enso rullar lastade i en vagn utan friktionshöjande material i golvet. Samtliga rullstaplar hade vid ankomsten flyttat sig ca 10 cm i samma riktning. Denna förflyttning har sannolikt orsakats av en eller flera rangerstötter. Någon förflyttning till följd av godsvandring kunde inte noteras.

*Stora Enso rullar transporterade mellan Fors och Trelleborg.*

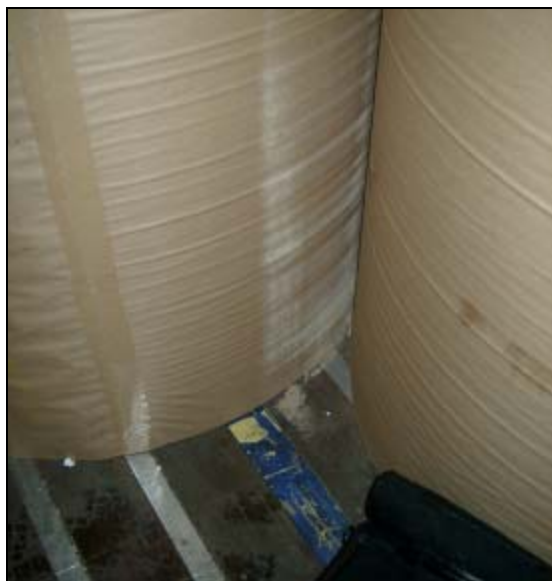
*Shaving skador på stående pappersrullar i ett växelflak.*

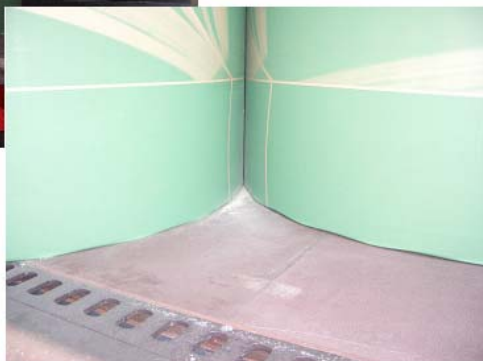
*Shaving damages on standing paper reels in a wagon exhibited at the Transport and Logistics exhibition in Munich in June 2005.*

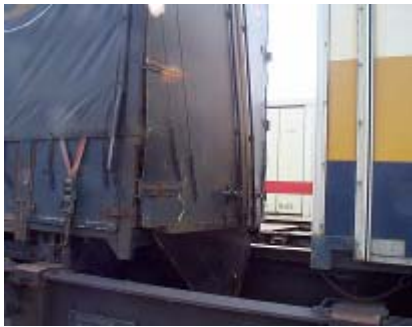
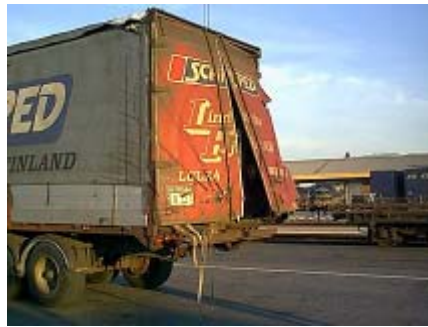
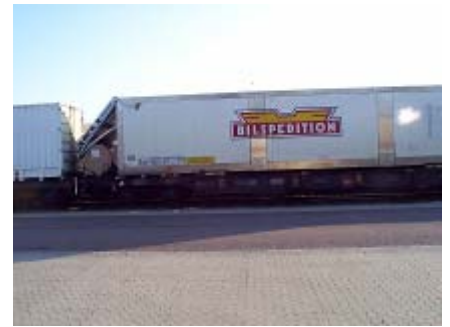
*Typical damages on intermodal cargo units caused by heavy shunting.*

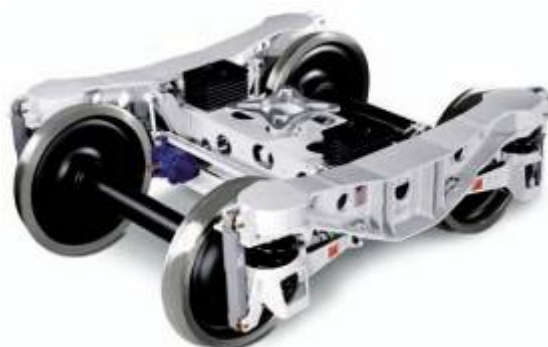
*TF25 bogie*

The test transports performed within this project has shown that it is possible to achieve excellent transport quality with this type of running gear.

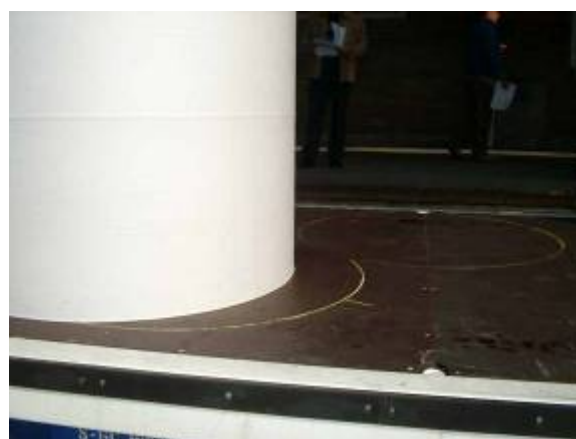
In Maschen (Hamburg) and Vienna the wagon was subjected to two heavy shunting shocks in the same directions, which caused all reels except those on Load Grip mats to move in the longitudinal direction. The reason why the reels in the right half of the wagon moved less than the ones in the left can be that buffers are placed between the two parts of the wagon.

*A photo from Vienna of reel no 6, the one that moved the most, 30 cm in longitudinal direction.*

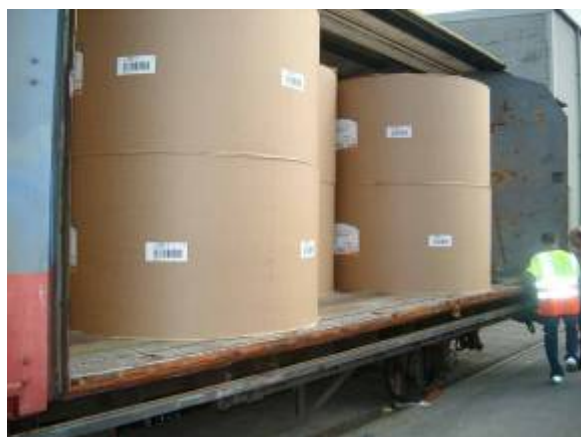
Only marginal movements were recorded in this wagon. This was the only wagon with Stora Enso reels. These reels were wrapped and had a bigger diameter than the other reels in the test. The wagon floor was coated with longitudinal stripes of friction increasing polyurethane foam.

*Inspection of the Stora Enso Fors reels in Vienna.*

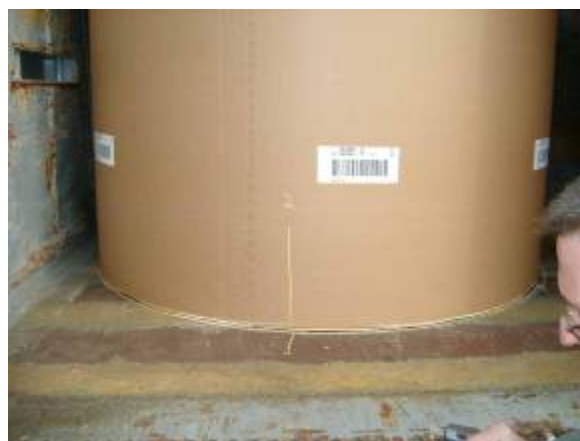
*A photo from Vienna of reel no 1 L with a very small rotation of 2 cm clockwise and a longitudinal movement of 4 cm.*

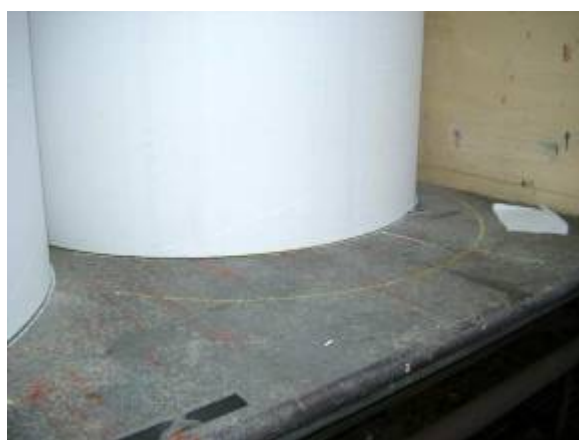
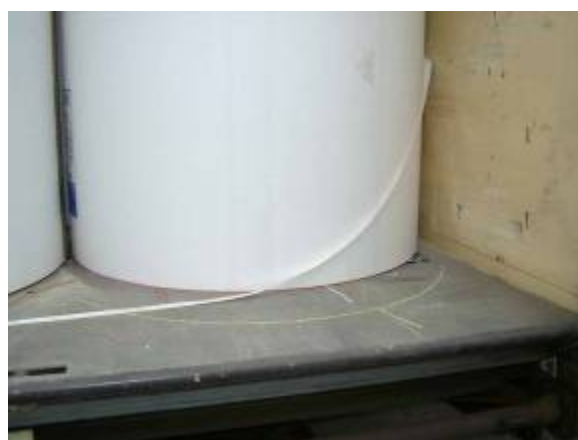
*Photos from Hallsberg and Vienna of the reel no 24 that moved the most in the Habbins wagon.  
Please note the round turn lashing lying on the floor.*

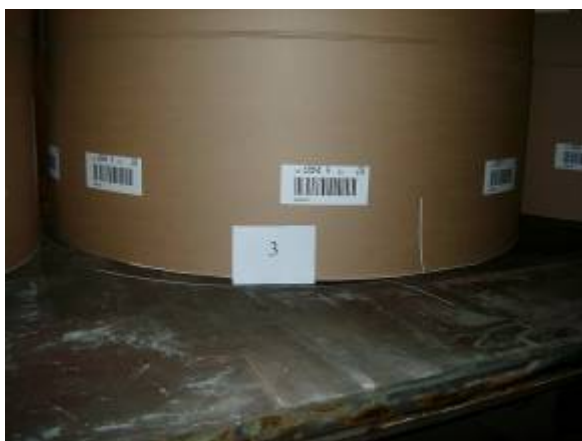
When inspected in Trelleborg, all reels had moved approximately 10 cm in the same direction, lengthwise in the wagon (direction 9). No particular rotation had occurred for any reel and no considerable movement crosswise in the wagons was found.

*The movement of stack number 3.*

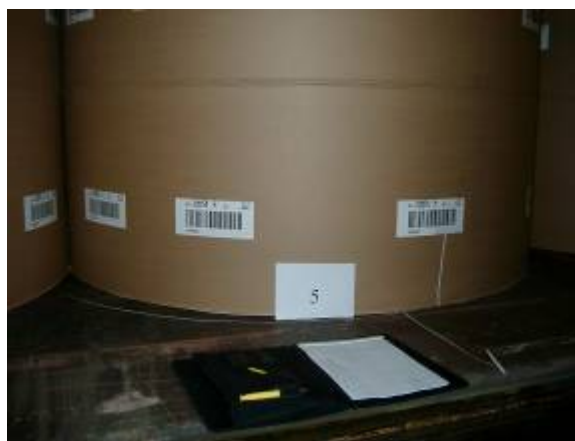
*The movement of stack number 5.*

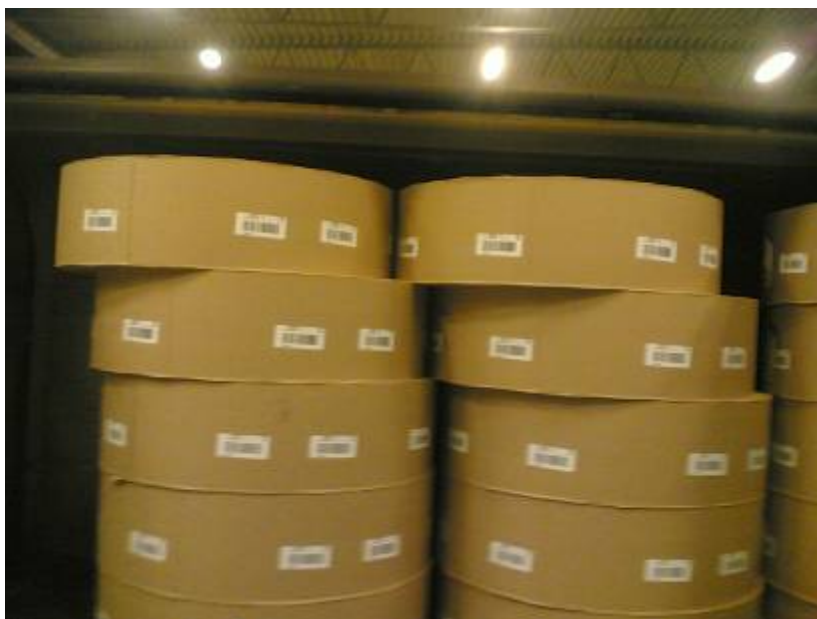
In previous transports of similar Stora Enso reels from Fors to Trelleborg, dislocations of reels in the top layers have been recorded. The photo below illustrates such a case.

*Dislocations of reels in a previous transport. (The photo is not taken of the reels in the test transport).*

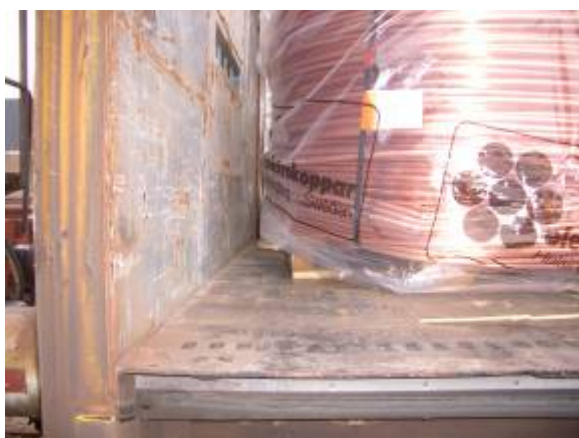
During the second impact, the coil on the far right in the sketch above moved against the end wall and the coil was deformed. This was due to the insufficient free space between the copper coils and the wagons fixed structure.

*The deformed coil on the far right after the second impact.*

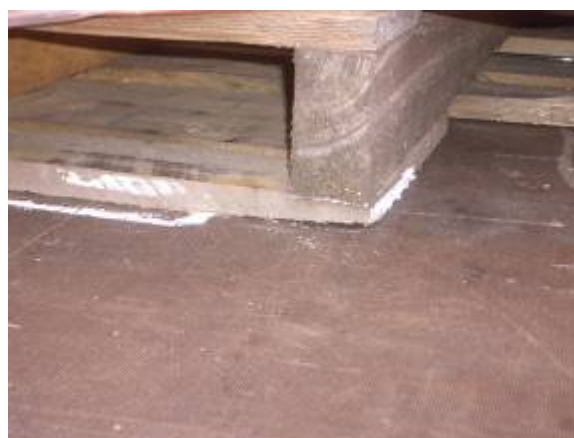
*The movement of the coils.*

Cargo that are not secured in any way and are allowed to slide during impacts, such as the copper coils and some of the paper reels, travelled great distances from their original position during shunting. Travelling distances up to 600 mm per impact were recorded repeatedly. In the shunting tests for paper pallets described in chapter 8 below in this report travelling distances above 1 m per impact were recorded. If the cargo comes in contact with end or side walls and slanted roofing during movements due to shunting impacts, it would probably be damaged or deformed, as was the case for the copper coils. This is due to the insufficient free space between the copper coils and the wagons fixed structure.

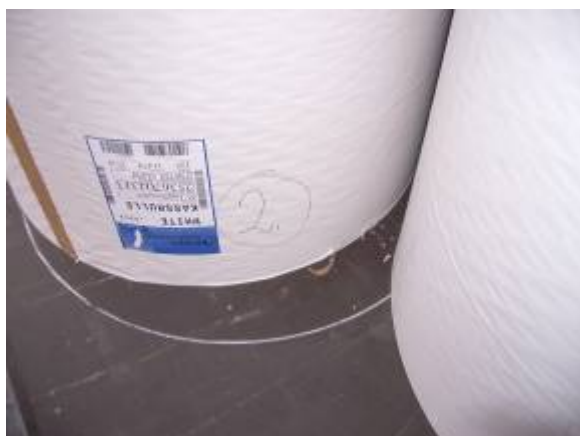
According to the results above when comparing the movements for reel number 5 and 6 to those of reel number 2 and 3, the rubber strips reduced the motions of the reels up to impact speeds of approximately 7 km/h. This speed corresponds to an acceleration of approximately 1.5 g in this wagon.

*The movement of reel number 2 after shock 2.*

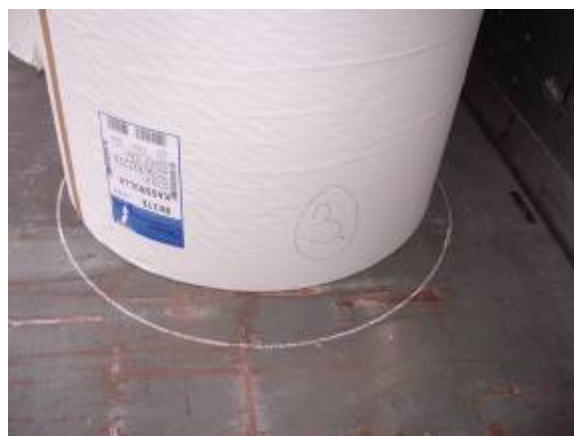
*The movement of reel number 3 after shock 2.*

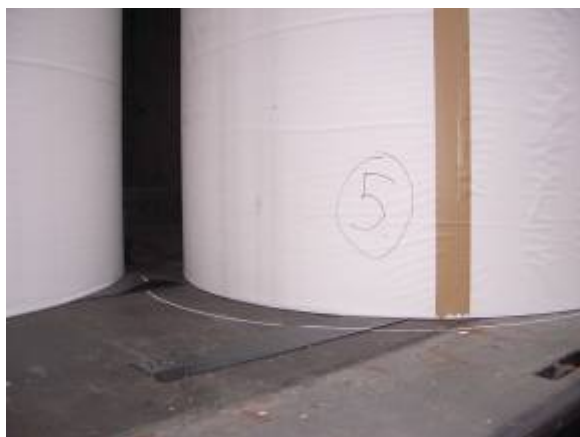
*The movement of reel number 5 standing on rubber strips after shock 2.*

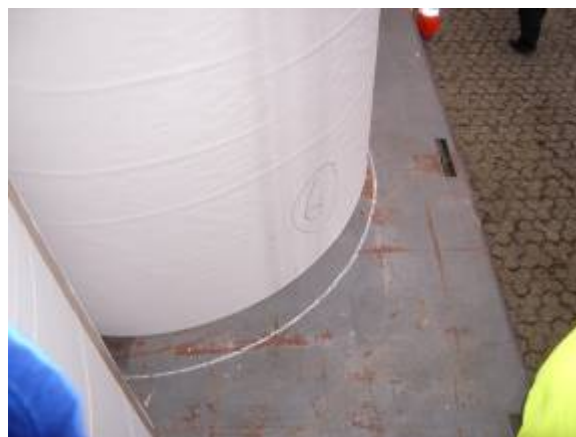
*The movement of reel number 6 standing on rubber strips after shock 2.*

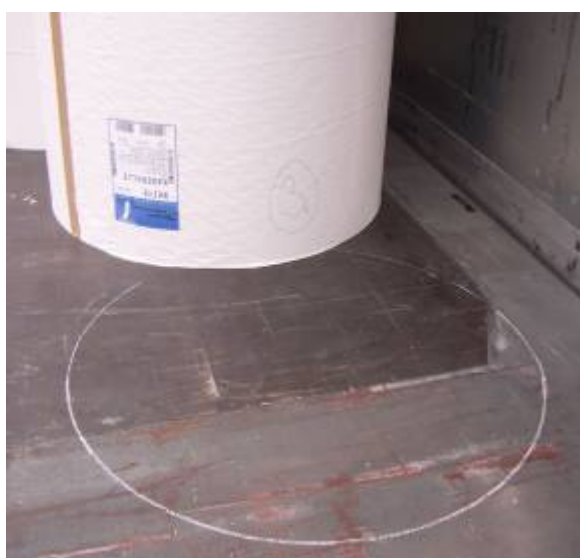
*The movement of reel number 3 after shock 5.*

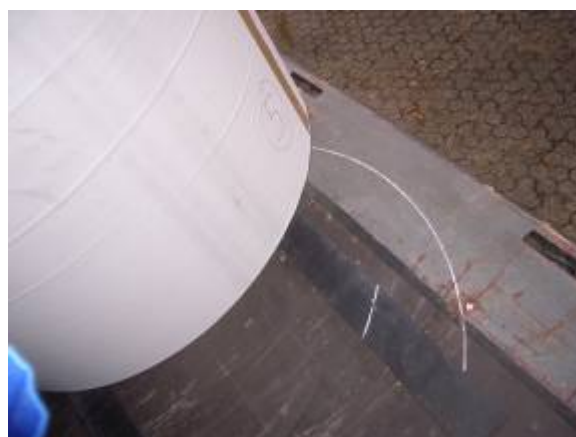
*The movement of reel number 5 standing on rubber strips after shock 5.*

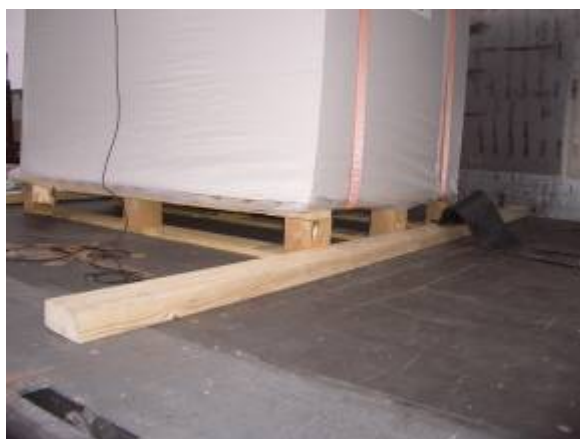
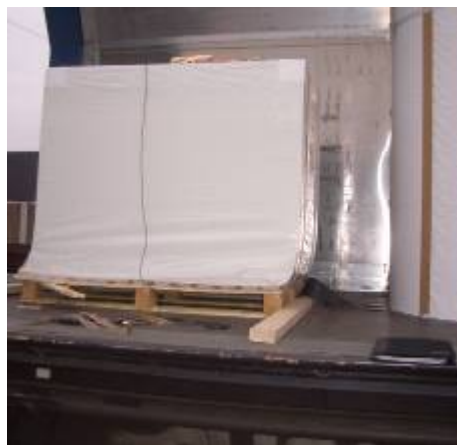
The shrink filmed pallet was heavily deformed and this method of palletizing cargo can not be said to be a proper choice for cargo that is only bottom block without any support of the cargo on the pallet. Further tests have been performed with stretch and shrink wrapped and hooded pallets which were allowed to slide during shunting, see chapter 8.

*The shrink filmed pallet with only bottom block was heavily deformed during the shunting tests.*

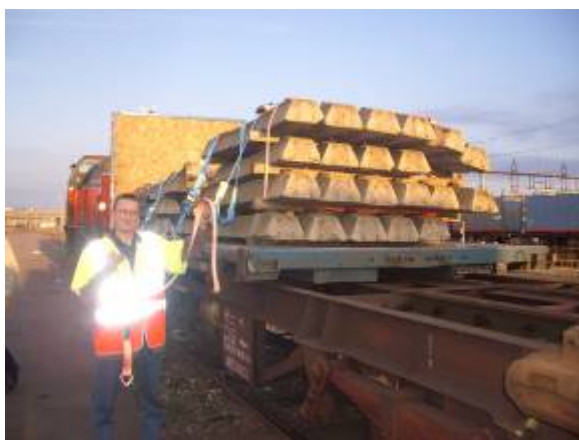
*The stow on the right in the photo above moved significantly during the fourth shock and the spring lashing snapped.*

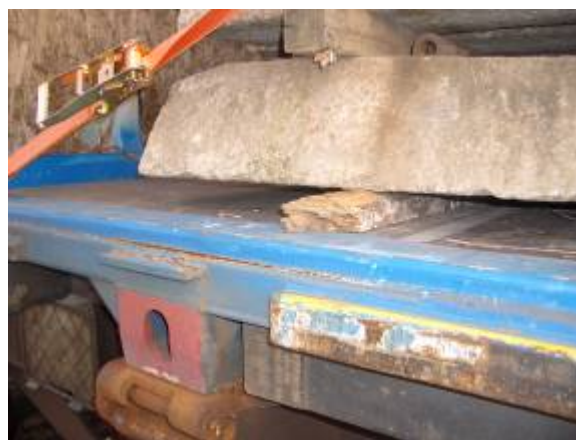
*The movement of the stow to the left in the sketch above after shock 4.*

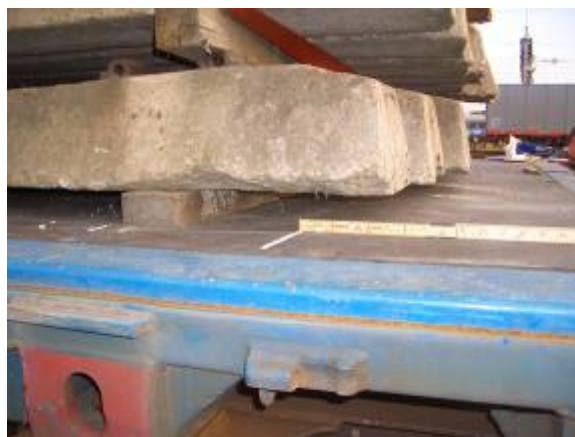
*The movement of the stow to the right in the sketch above after shock 4.*

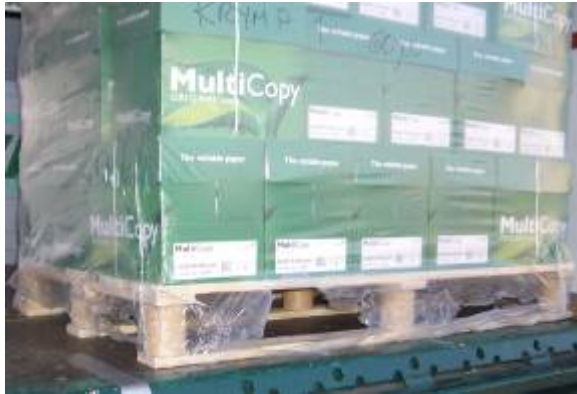
The pallets from Denmark with shrink and stretch hoods showed some handling damages in the plastic film see photos below. This influenced their performance during the tests and the misleading results are for that reason excluded from the report. Hence, these pallets were tested again, see section 8.5.

*Shrink hood pallet 1 and 3.  
The plastic film has been torn apart when handled by a fork lift.*

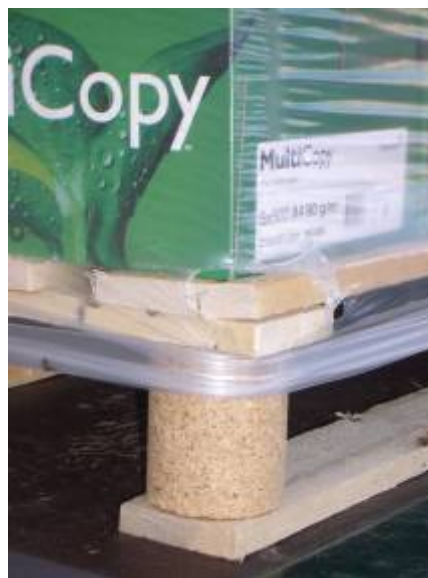
*Stretch hood pallet 2. The plastic film  
has been ripped through by the sharp  
corners of the wooden pallet.*

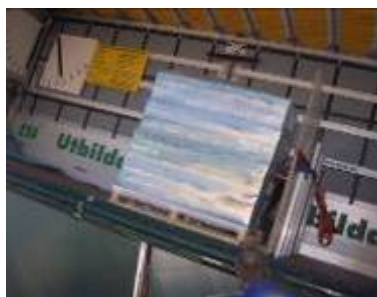
*Pallet 1 at 27 degrees inclination.*

Pallet 1 and 2 survived the inclination to about 28 degrees and the boxes in the top layer had at this point moved approximately 50 mm from their original position. At the inclination of 30 degrees they were still stable but had been quite deformed.

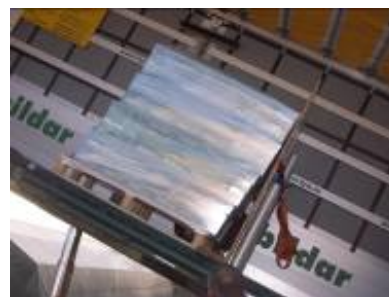
Inclination [degrees]	Distance to barrier [mm]			Accumulated movement [mm]			Comment
	A	B	C	A	B	C	
0	219	207	203	0	0	0	
10	219	207	203	0	0	0	
15	219	206	202	0	1	1	
20	218	204	198	1	3	5	
25	218	193	180	1	14	23	
27	216	185	165	3	22	38	
30	210	168	135	9	39	68	
34	-	-	-	-	-	-	<b>Collapsed</b>

*Pallet 1 at 34 degrees inclination*

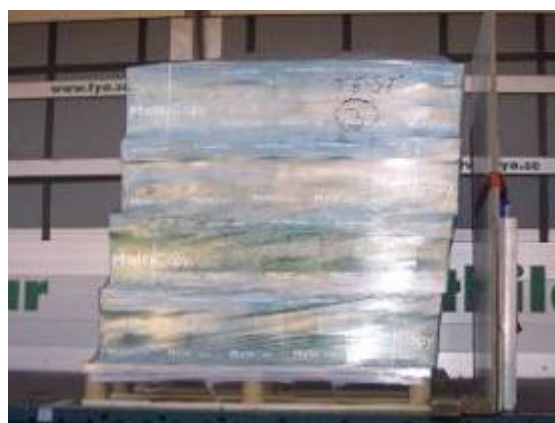
Inclination [degrees]	Distance to barrier [mm]			Accumulated movement [mm]			Comment
	A	B	C	A	B	C	
0	217	205	201	0	0	0	
10	217	205	201	0	0	0	
15	217	203	200	0	2	1	
20	217	200	196	0	5	5	
25	216	190	176	1	15	25	
27	215	181	160	2	24	41	
30	208	165	131	9	40	70	
33,5	-	-	-	-	-	-	<b>Collapsed</b>

*Pallet 2 after the inclination test.*

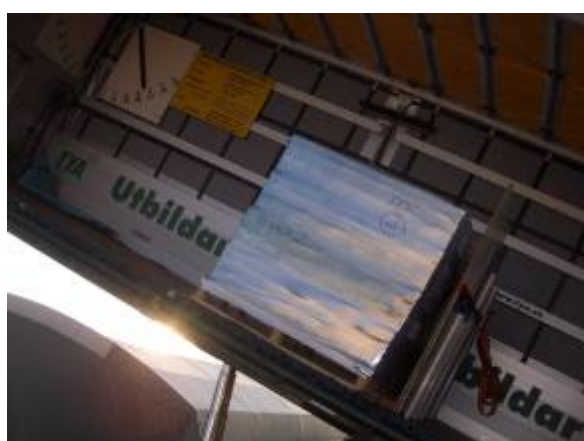
*Pallet 3 at 35 degrees inclination*

Pallet 3 was only slightly deformed at the inclination of 27 degrees and at the inclination of 35 degrees, the top boxes had only moved 45 mm but the whole pallet was on the brink of tipping over.

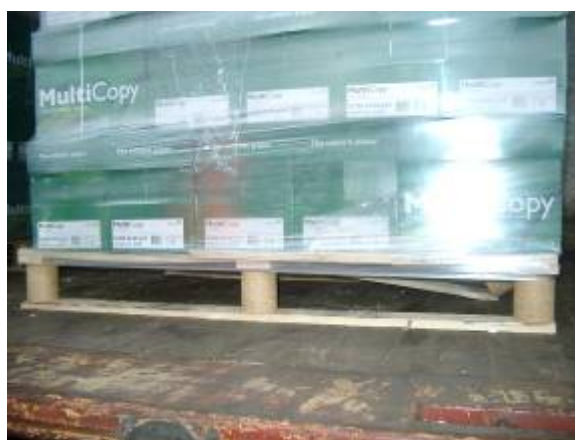
*\* This wooden pallet broke during the test and splinters from the overlaying boards were protruding upwards, into the cargo and hindered its movement against the pallet. See photo below.*

*Pallet 4 with splinters from the wooden pallet protruding upwards into the cardboard boxes after the shock.*

In case of pallet number 4 a wooden board was broken and held some of the cargo back. Therefore the shrink film around this pallet was not subjected to as high loads as for the rest of the pallets.

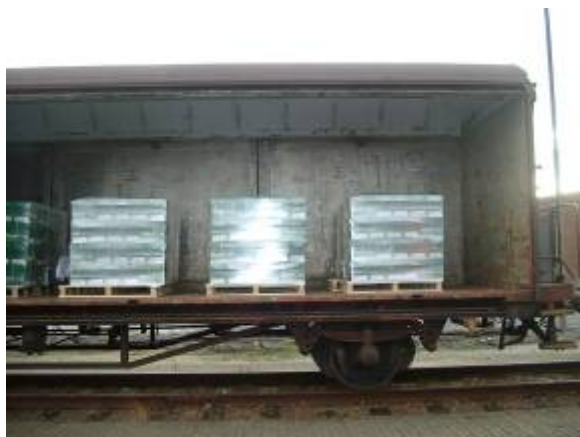
*Pallet 8, 4 and 7 after the shunting test.*

Three of the pallets, number 4, 7 and 9, performed better than the rest. On these pallets the plastic film held the cargo and the wooden pallet together well enough to transmit the mass forces to the pallet and they all slid a distance of approximately 100 mm against the wagon floor.

Surprisingly, this was not the case for pallet no 8 which was wrapped with the same amount of plastic as pallet number 9. It may have been wrapped in an inappropriate way or the film may have been damaged during handling, but no imperforations was noted prior to the impact. The pallet may also have been more firmly constrained by the uneven flooring than the rest of the pallets.

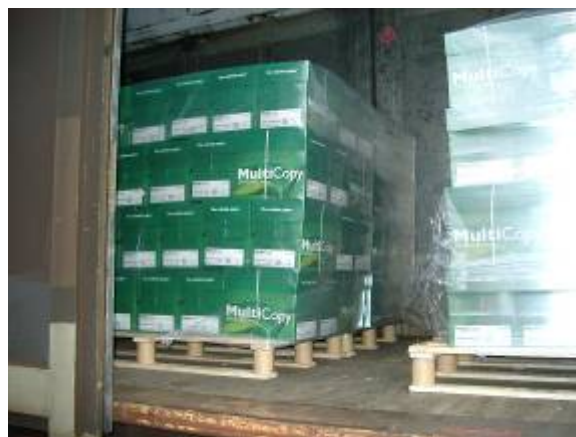
For all pallets, the cargo slid primary at the bottom against the wooden pallet and not so much between the layers. Only the pallets with the very least film had a tilted shape after the impact, while boxes on the others had moved almost as a solid block, see the photos below.

*Pallet 3 and 8 after the shunting test.*

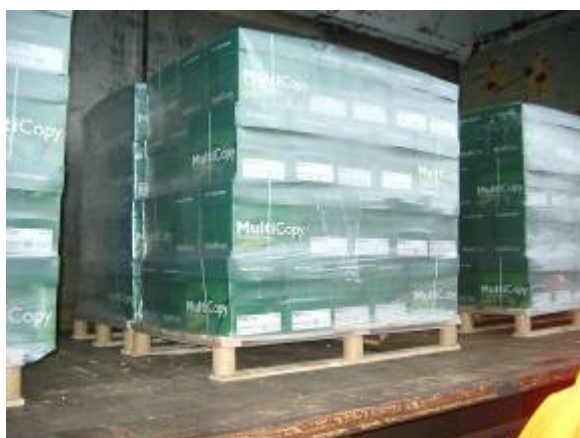
*Pallet 4 after the shunting test.*

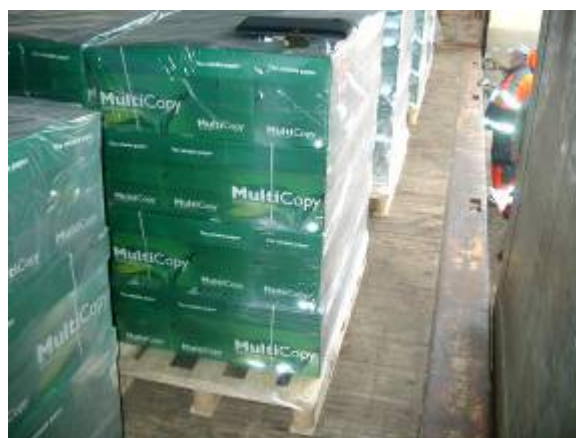
*Pallet 3 after the shunting test.*

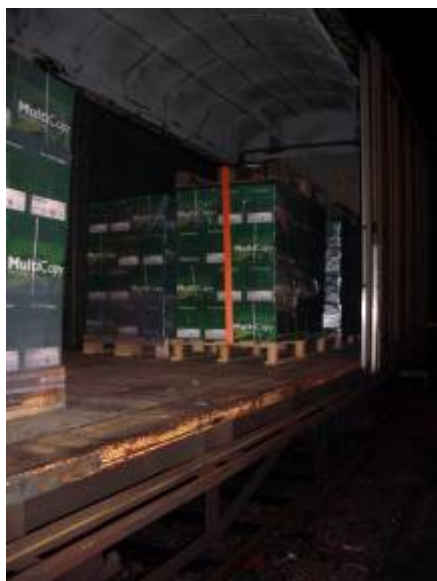
\*\* The cardboard boxes on the pallets A, B and C were secured to the wooden pallet by the means of a web lashing, as seen in the photos below. The cells in the column for the movement of the cargo against the pallet (II) are therefore shaded for these pallets.

*Pallet A after shock 2.*

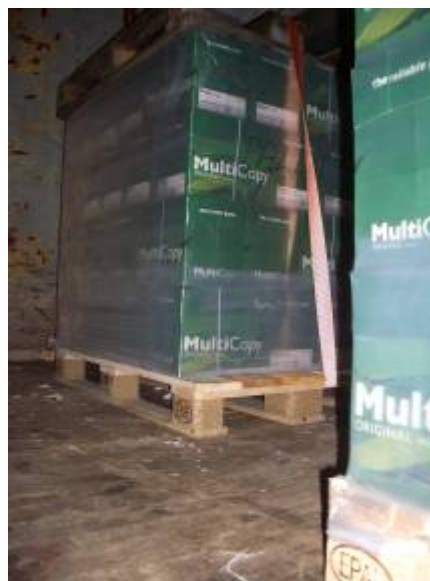
*Pallet 1 after shock 4.*

Even though pallet number 1 was wrapped with the most amount of plastic film of all the pallets in the test, it collapsed during the second impact. The pallet was very reluctant to move against the wagon floor even after the cardboard boxes had been tied to the wooden pallet and it was probably experiencing a higher friction force than the rest of the pallets. Considering the roughness of the wagon floor and the wooden pallet it may even be considered to be on

the verge of mechanical locking. Also, slight damages to the film around the corners of the wooden pallet were noted prior to the test and this in combination with it's reluctance to move, may be the explanation for why the plastic yielded.

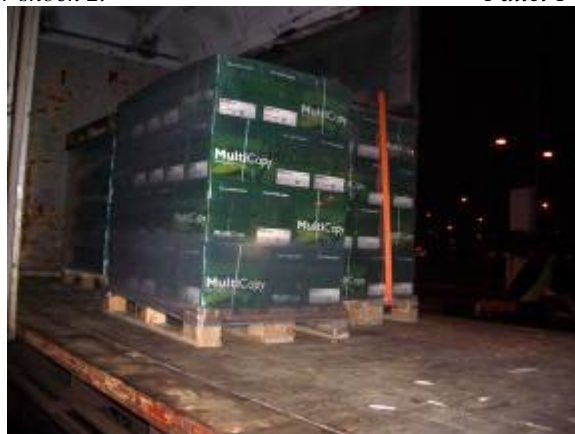
*Pallet 4 and 5 after shock 4.*

Pallet number 5 was wrapped with the least amount of plastic film, and it was also the first one to collapse, already at the first, low speed impact. It can also be noted that damages to the film around the corners of the wooden pallet were noted prior to the test.

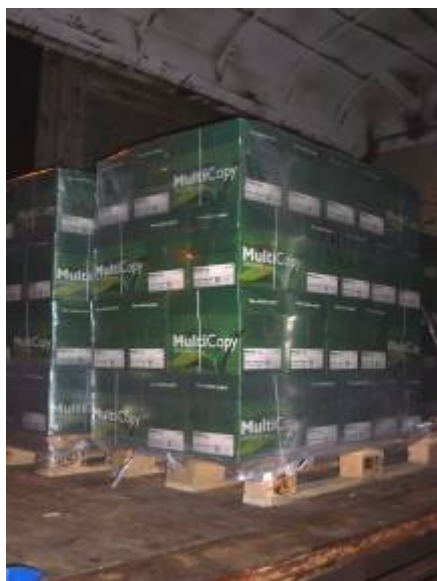
*Pallet 5 after shock 1.*

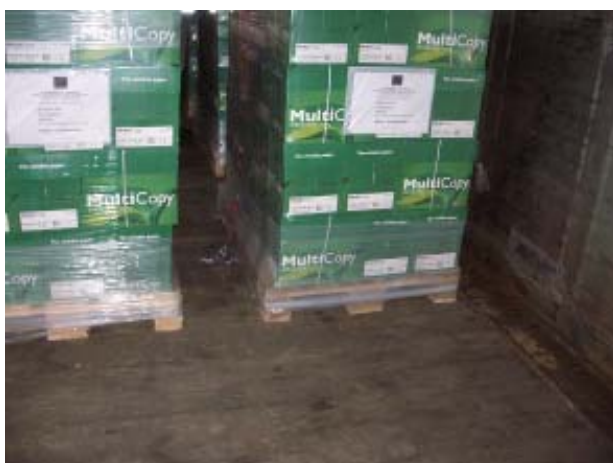
*Pallet 7 to the left before shunting.*

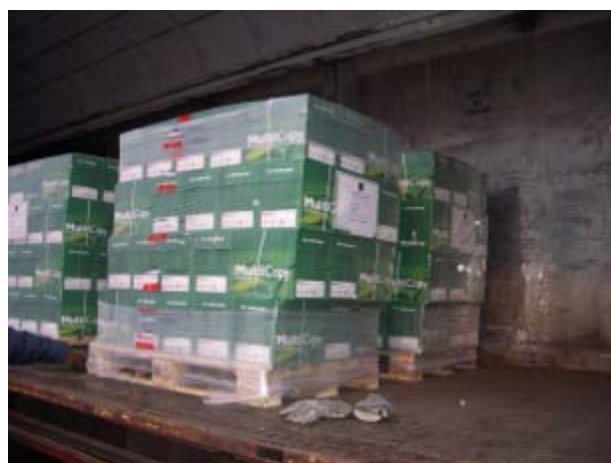
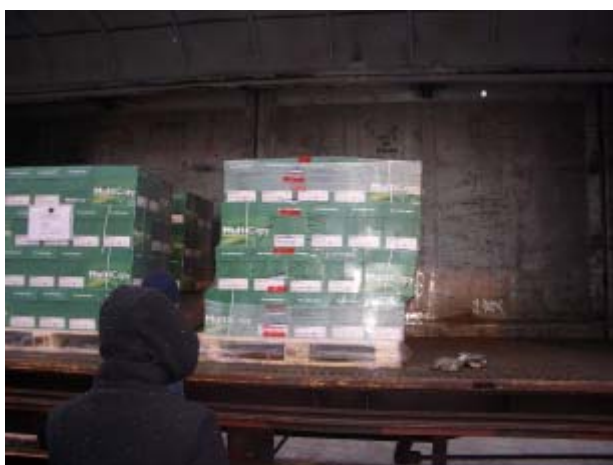
During the first shock pallet 7 collapsed and to prevent the boxes to be all over the wagon floor the cardboards were secured to the wooden pallet by the means of a web lashing, see the photos below.

*Pallet 7 after shock 1.*

*Pallet 7 after the first shock.*

The pallets 5 – 8 were covered with different numbers of stretch hoods and independent of the number of hoods significantly movements among the cardboard boxes were noted. Even though pallet number 7 was covered with 3 hood layers both on the top and at the bottom, it collapsed already during the first impact.

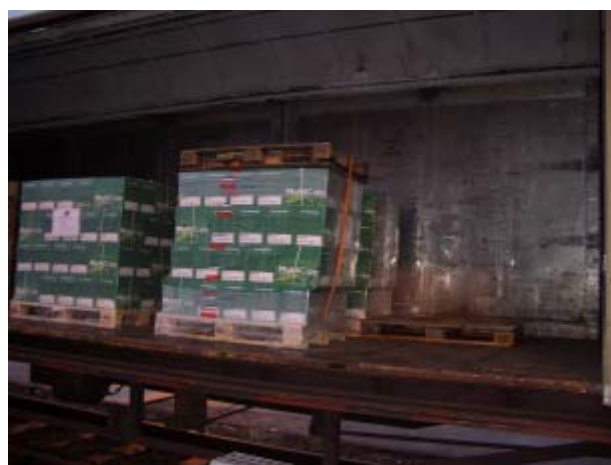
*Pallet 7 secured to the wooden pallet by lashing.*

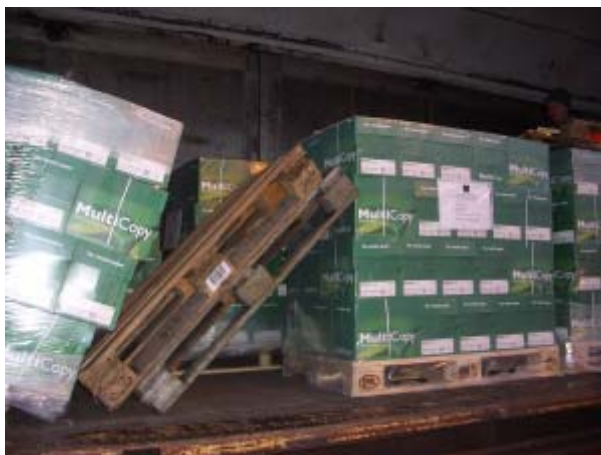
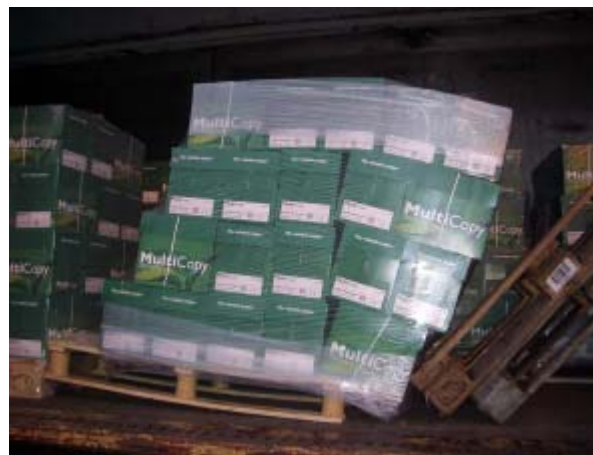
During the second shock the cardboard boxes on the wooden pallet number 8 fell off. When the counter weight wagon ran into the test wagon, in the opposite direction of the two initial shocks, the boxes went back upon the wooden pallet again. See below photos.

*The collapse of pallet 8 after shock 2.*

Pallet number 8 that was covered with the largest numbers of hood layers, 6 layers both on the top and at the bottom of the pallet, collapsed at the second impact. It can be noted that a lengthwise rip half way up the pallet was found prior to the tests and that this rip may be the explanation for why the stretch hoods yielded totally.

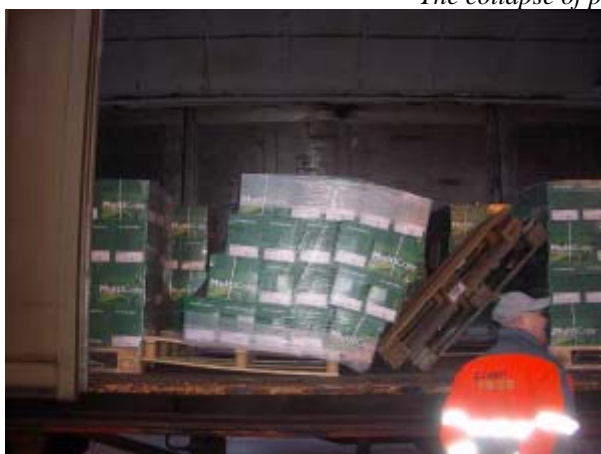
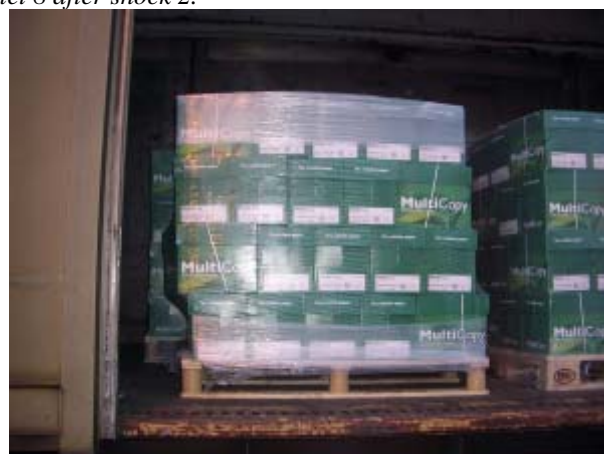
*The collapse of pallet 8 and the jump back of the cargo on the pallet during the counter shock.*

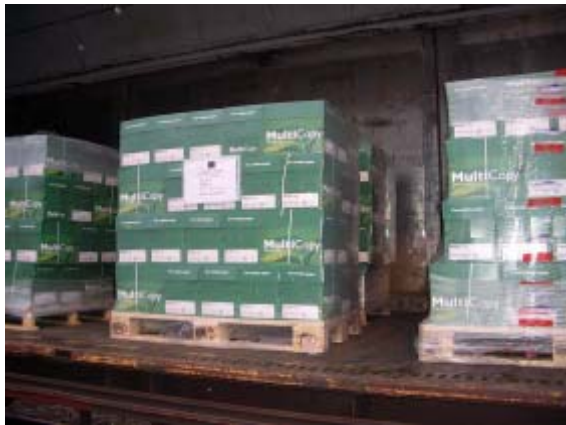
Pallet number 2, 3 and 4 hardly showed any dislocations of the cargo, neither against the wooden pallet nor against each other, after any of the impacts. However, they all slid considerable distances over the wagon floor.

*Pallet 2 in the middle of the photo after the first shock.*

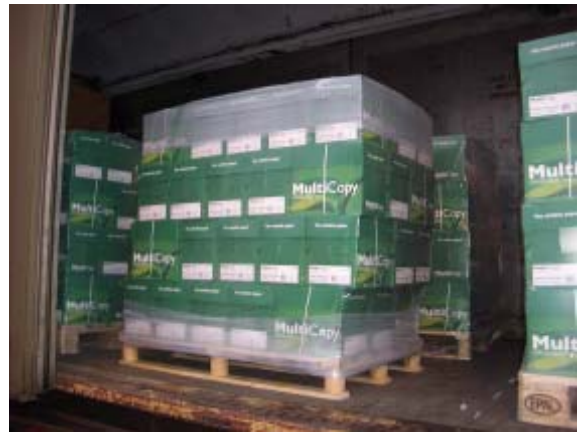
*Pallet 8 after shock 1.*

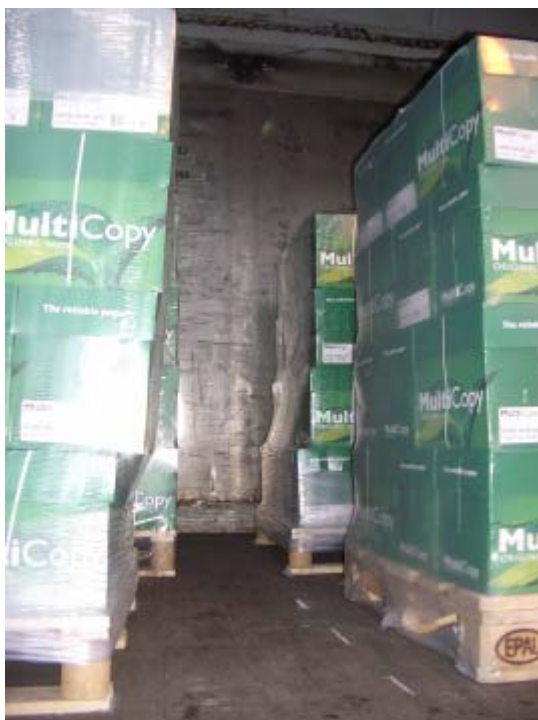
*A close-up of pallet 8 in the foreground to the left and pallet 6 in the background to the right after shock 1.*

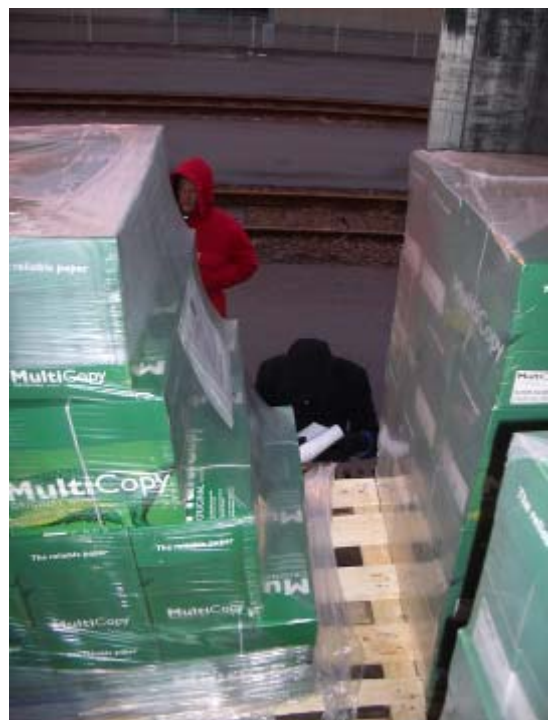
*Pallet 8 after the second shock.*

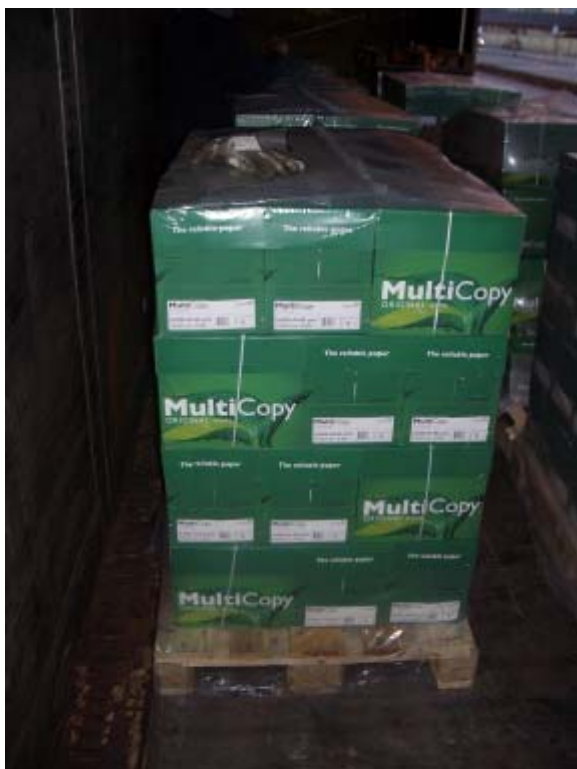
*Pallet 1 after shock 2.*

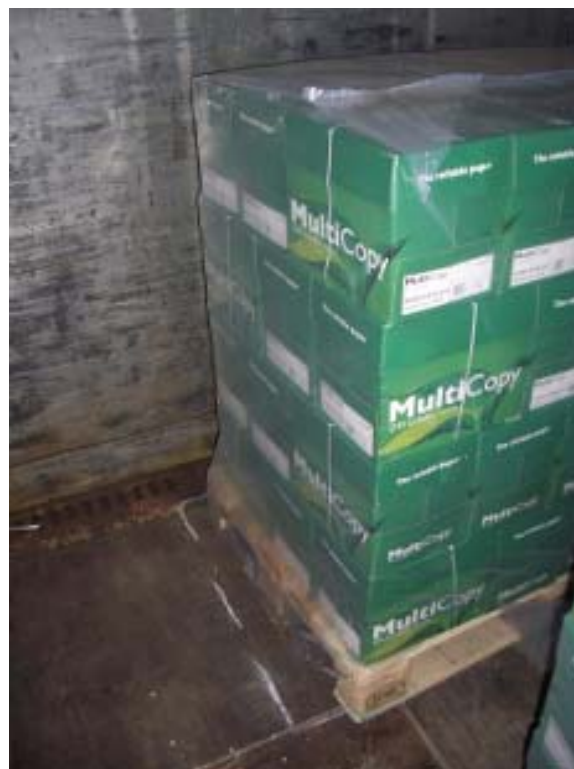
*Pallet 1 after the counter shock.*

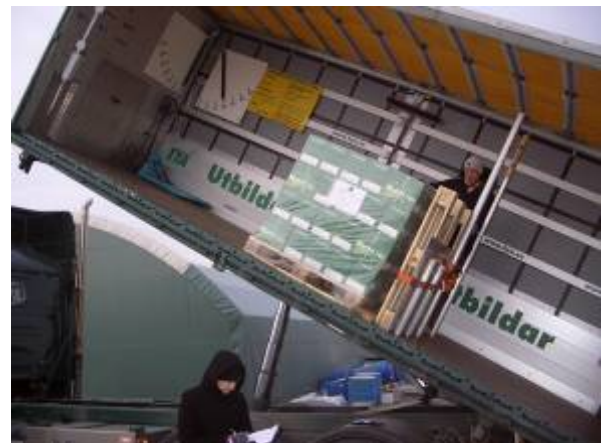
*Pallet 1 at 30 degrees inclination.*

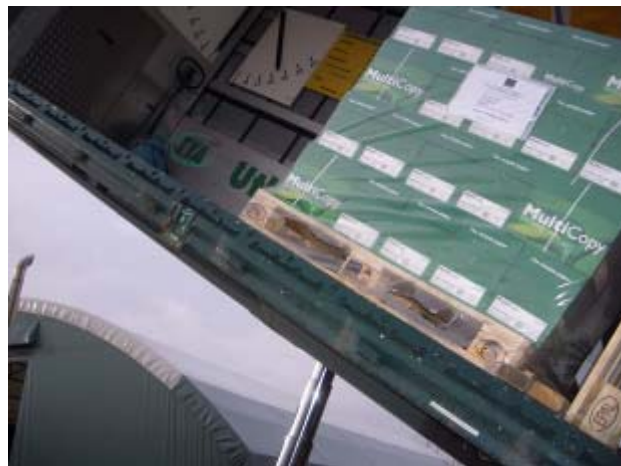
*36 degrees inclination and near the brink of collapsing of pallet 2.*

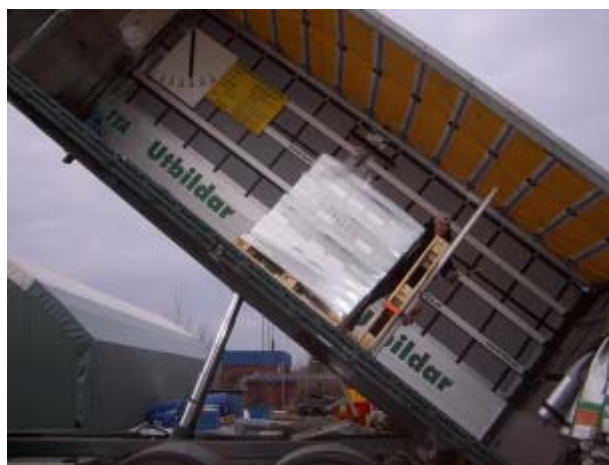
This pallet wrapped with 577 g stretch film started tilting at 36 degrees and the boxes in the top layer had at this point moved approximately 50 mm from their original position. As seen in the photos below, the pallet was only slightly deformed, but the whole pallet was at this

*Inclination of 36 degrees of pallet 6.  
The pallet is near the brink of tipping.*
